WIND EFFECTS ON ASPHALT SHINGLES

Timothy P. Marshall*, Scott J. Morrison, Richard F. Herzog, Jeffrey R. Green
Haag Engineering Co.
Irving, Texas

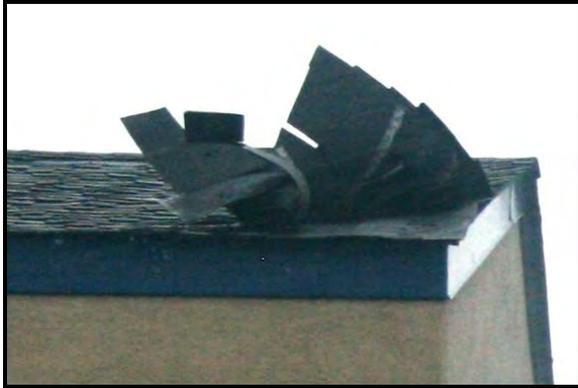
Figure 2. Uplift of asphalt shingles on the corner of a gable roof during Hurricane Gustav. Image by Tim Marshall.

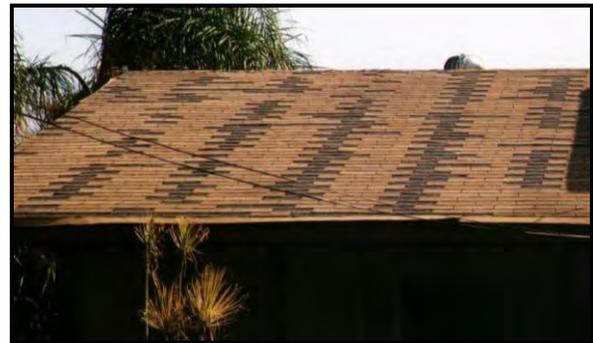
Failures of the three-tab shingles typically occurred when the tabs were not bonded to the sealant strips and were lifted, breaking at the tops of the tabs. Failure was more likely in those tabs which bridged the butted end joints of underlying shingles. The result was a "zipper" like pattern of missing tabs that extended upslope from the eaves to the ridges (Fig. 6).

Figure 6. Wind damage to asphalt shingles installed in the racking or "straight-up" pattern after Hurricane Frances.

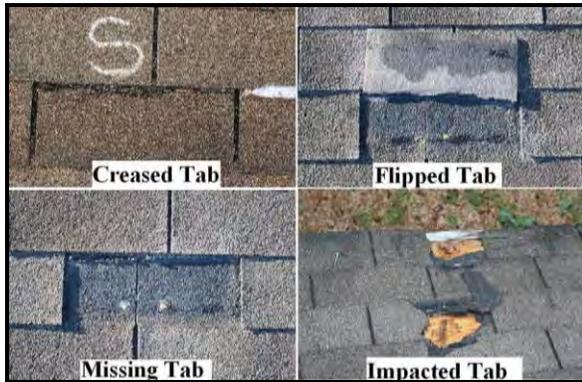
Four primary modes of asphalt shingle failures occurred during Hurricane Frances: 1) creasing, 2) flipping, 3) tearing/removal, and 4) abrading from flying or falling debris (Fig. 7). It was not uncommon to find multiple modes of failure on a roof or slope. In some instances, entire shingles tore away when the fasteners pulled through the mats. Noone and Blanchard (1993) reported similar modes of failure with asphalt shingles during wind storms.

Figure 7. Various types of wind damage to asphalt shingles.

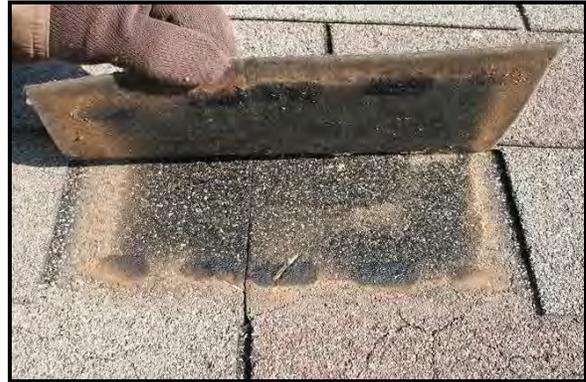
Figure 8. This aged tab had little sealant bond strength and could be easily lifted by hand. Note the crazed cracks on the shingle surface.

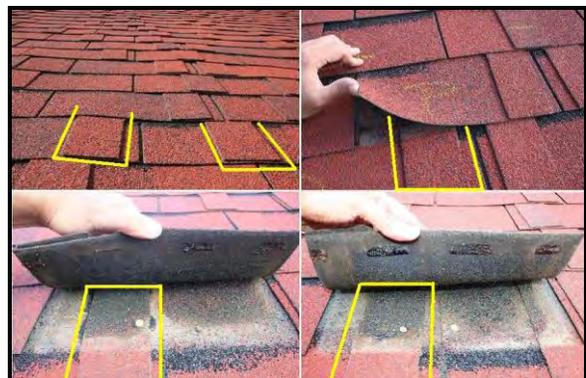
The cut-out design in the three-tab shingle makes them more prone to flipping in the wind after sealant failure. However, the authors have found other shingle designs that are particularly prone to wind damage. One manufacturer makes a three-tab shingle with a small, rectangular tab adhered to the top of the shingle. This rectangular tab prevents sealant on the bottom side of the overlying tab from bonding fully to the underlying tabs. Also, an air gap is created between rectangular tabs allowing wind to get underneath them. The result is the uplift and removal of the tabs at relatively low wind speeds (Fig. 9).

Figure 9. Rectangular tabs (outlined) adhered to the tops of the shingles prevented full contact of the overlying tabs and created air gaps between the tabs.

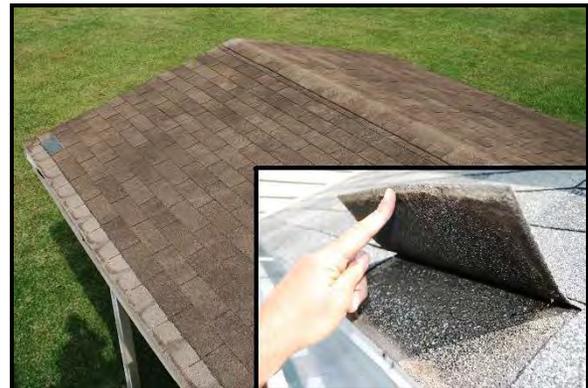
Another factor in wind resistance is how well the asphalt shingles are fastened to the roof deck. The authors frequently have found first shingle courses are not bonded to the starter shingles. This condition occurs when the starter shingles are not installed correctly (with the tabs cut off such that the sealant strip is placed at the roof edge.) Thus, the first shingle course is not bonded to the roof and can be removed in relatively low wind speeds (Fig. 10). Such shingles can also be lifted easily with a finger.

Figure 10. Loss of first tab course from Hurricane Ike as the tabs were not sealed down due to improper installation of the starter shingles as shown by inset.

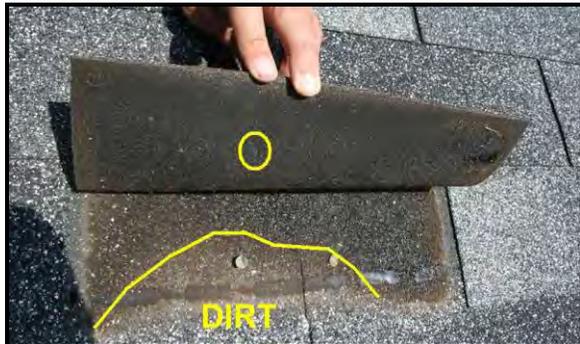
Shingle manufacturers require that fasteners be driven flush to the shingle surfaces and be installed in the correct locations. Underdriven fasteners can prevent the sealant strip from contacting overlying shingles. As a result, overlying shingles remain elevated and the fasteners eventually protrude through it. Typically, sealant that does not bond remains smooth. Dirt and debris can accumulate on the sealant rendering it ineffective (Fig. 11). Overdriven fasteners can dimple the shingles also preventing sealant transfer or cut through the shingles. Wind would not pull out the fasteners and leave the shingles intact.

Figure 11. Elevated nail (note shadow) prevented this tab from bonding to the sealant strip. Note the dirt residue and smooth sealant on the underlying shingle and lack of sealant transfer to the bottom side of the overlying tab. The yellow circle highlights the indentation of the nail head in the bottom of the overlying tab.

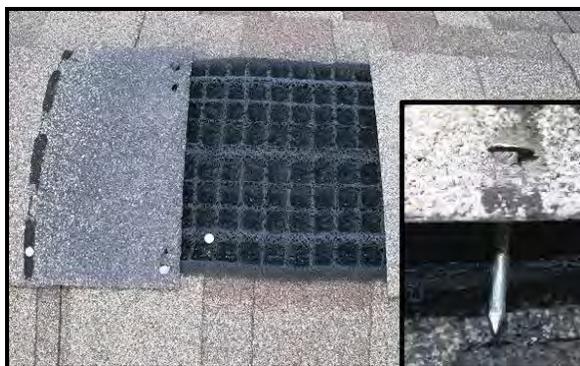
Fasteners also must be long enough to penetrate the plywood or OSB roof decking. Longer fasteners are needed to attach ridge tabs, especially when installed over high profile plastic or fabric type ridge vents. The authors have found many wind damaged ridge shingles because the fasteners were too short (Fig. 12).

Figure 12. Loss of ridge tabs due to insufficient fastener length (inset).

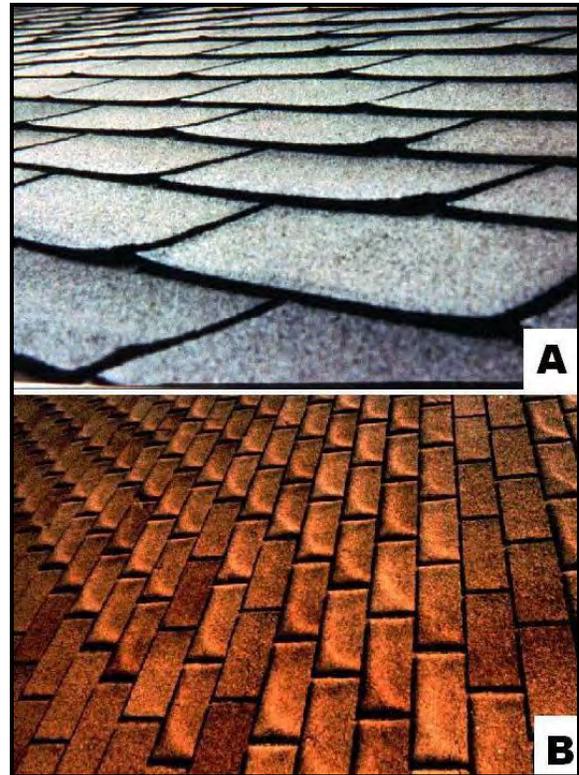
Cupping and clawing occurs slowly and progressively as the shingles shrink. Cupping results when the top portions of shingles shrink more than their bottoms, causing the unrestrained corners to curl upward. Clawing is the opposite of cupping and involves the corners curling downward (Fig. 13).

Figure 13. Examples of cupping (A) and clawing (B) of asphalt shingles. These conditions are not caused by storm effects.

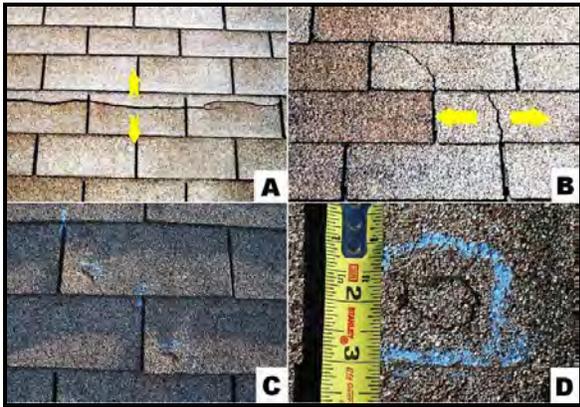
Horizontal splits occur as the shingle shrinks between the two lines of anchorage. The middle of the shingle is fastened mechanically to the roof deck while the bottom edge is secured with sealant. Horizontal splitting occurs between the two lines of restraint.

Vertical splits occur as the top shingles shrink over the butted joints on underlying shingles. On shingles installed in racking or straight-up patterns, splits extend vertically upslope. On shingles installed in a diagonal manner, splits are curved, extending upslope on overlapping portions of the shingles. Generally, torn shingle pieces remain bonded to the underlying shingles. In some instances, shear failure occurs in the sealant and the overlying shingle does not split. Occasionally, curved and round splits occur as a shingle tears around the underlying sealant dollops. In some instances, shingle corners become elevated (Fig. 14).

Figure 14. Examples of shingle splitting: a) horizontal, b) vertical, c) curved, and d) rounded. Such splitting is not caused by wind.

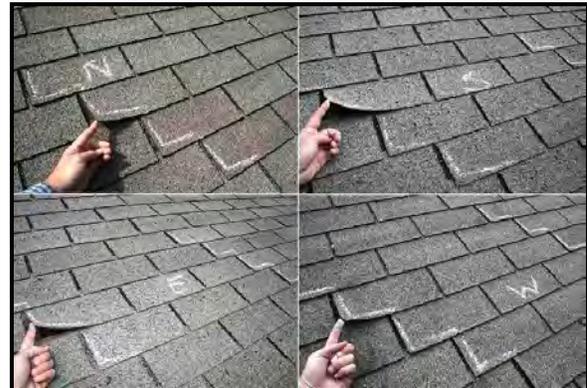
Figure 16. Roof in Norman, OK where overlaps were not bonded to the underlying shingles on each directional slope (indicated). This condition was not wind-caused.

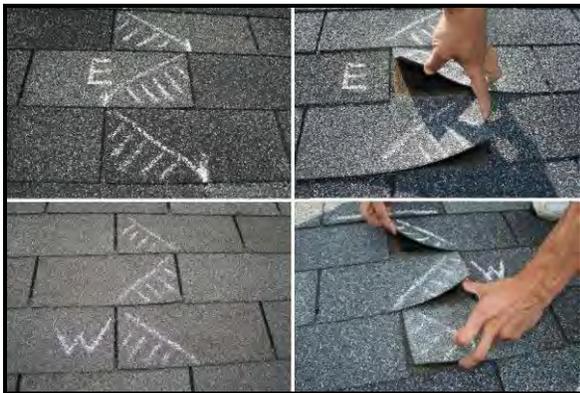
Figure 18. Roof in Minneapolis, MN where overlaps were not bonded to the underlying shingles on directional slopes (indicated). This phenomenon was not wind-caused.

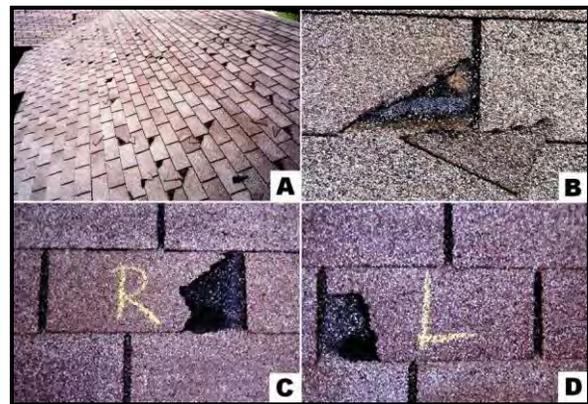
Intentional damage to the roof usually involves recognizable patterns. In many instances, the right or left corners of shingles/tabs are removed instead of the entire shingle/tab. Also, shingle damage tends to be concentrated in walkable areas of a roof, away from roof edges (Fig. 19). Sometimes, shingles are broken and torn away removing portions of the sealant strip indicating the shingle was well bonded. Close examination of the sealant strip can reveal impressions of tool marks used to pry up the shingles. Occasionally, the roof slope containing the damage does not correlate with wind direction. A plot of the damage on a roof plan diagram can better show such patterns.

Figure 19. Intentional damage to roofs to simulate wind damage: a) broken corners upslope away from roof edge, b) broken corner left nearby, c) torn right edge of tab, and d) torn left edge of tab.

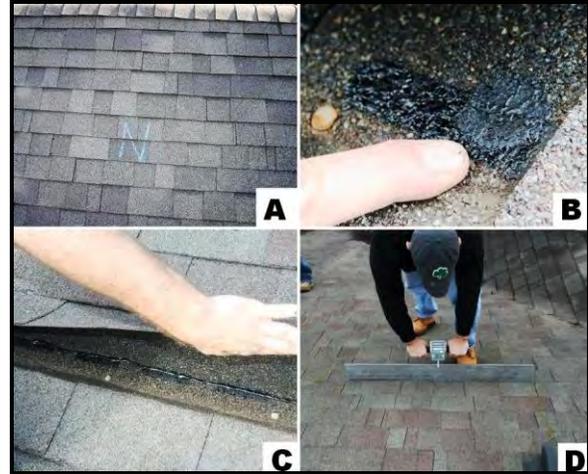
Uplift tests were performed by the authors on a building roof that was not damaged by Hurricane Ike. Strengths of the shingle sealant were determined by pulling upward on sealed shingles using a specially made metal bracket that was inserted beneath the bottom edges of the shingles and using a dynamometer (digital force gauge) to measure the uplift force (Fig. 20).

After the shingles were mechanically unbonded, they were sealed with two common types of sealant. Sealing included both the standard-size dollops and .64 cm (1/4 in.) wide continuous beads. After a 30-day cure time, the shingles were pulled again. Strengths of the dollops and continuous beads both exceeded the original sealant strengths. Average strengths of the dollops exceeded existing sealant strengths by more than 70 percent while the average strengths of continuous beads exceeded existing sealant strengths by more than 400 percent. In some instances, the bond between the repaired shingles was so strong that uplifting tore the underlying shingles.

Figure 20. Pull tests on laminated asphalt shingles: a) undamaged shingles, b) dollop of asphalt plastic cement applied under shingle, c) bead of asphalt plastic cement applied under shingle, and d) pull test after 30 days.

Unbonded shingles can be sealed in accordance with the Asphalt Roofing Manufacturers Association (ARMA 2006) guidelines. For three-tab shingles, dollops of asphalt roofing cement, about the size of a quarter coin, can be placed on the underlying shingle to secure the lower corners of the overlying tabs. For laminated shingles, four dollops of asphalt roofing cement can be placed on the underlying shingles to secure the bottom edges of the overlying shingles. The dollops are placed 2.5 cm (1 in.) inwards from the ends of the overlying shingles with equal space between.
