Ball Peen Hammer Test

A HAAG Engineering Co. Publication

Ball Peen Hammer Test
Written by Tim Marshall, P.E. with
assistance from Scott Morrison, P.E.

Revised 2003

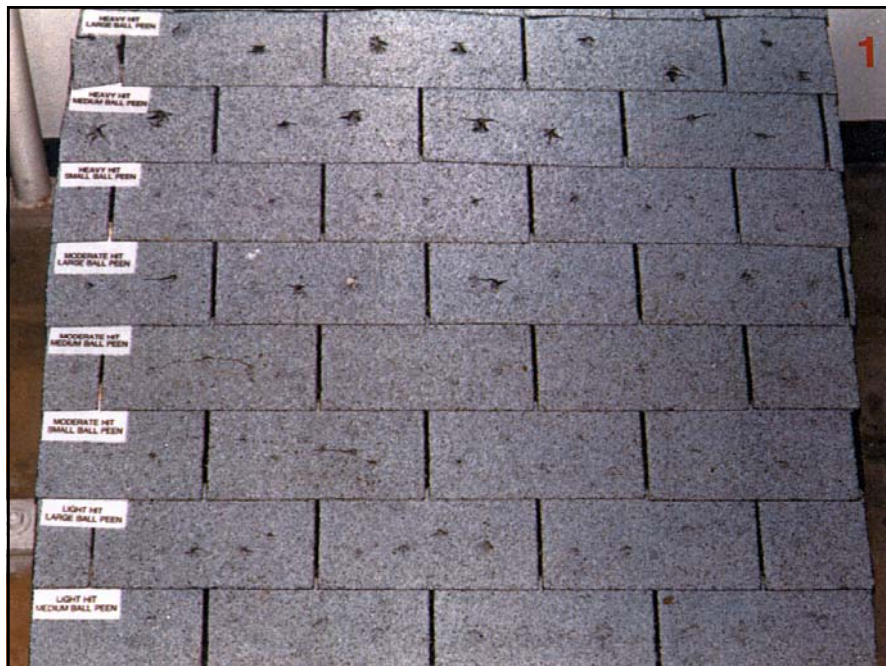
Photograph 1: Composition shingle roof panel

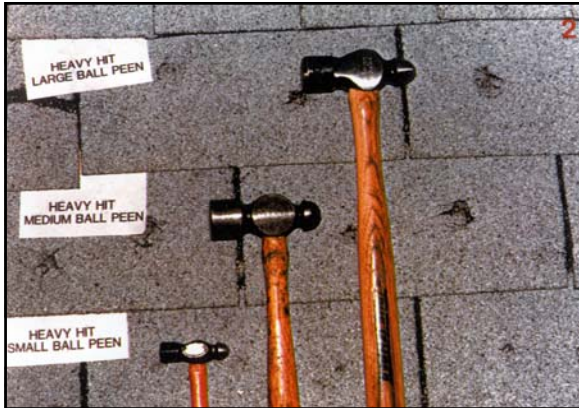
Photograph 2: Comparing ball peen hammer sizes

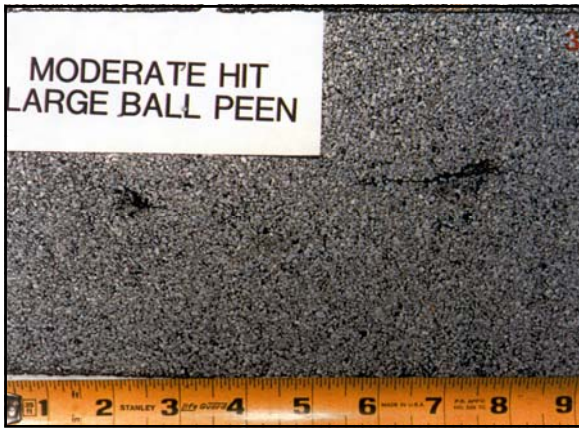
Photograph 3: Large ball peen, moderate hit

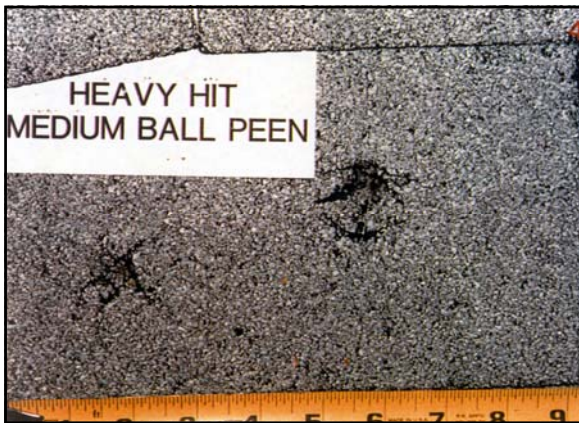
Photograph 4: Medium ball peen, heavy hit

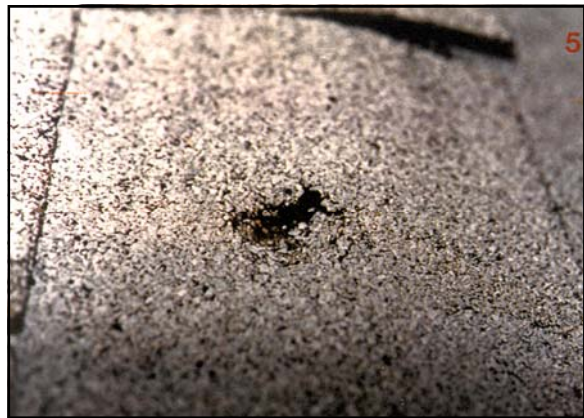
1. *Round Marks* resulted from heavy blows of the hammers. Upslope portions of the impacted area were driven into the decking, whereas downslope portions were deformed downward. The marks appeared half-moon shaped with the deepest indentation on the upslope side. Granules were dislodged from along the impact perimeters. Granules were smeared or crushed to a powder along the upslope perimeter of the impacted area as well as within the area driven to the deck. Surfaces of the indentations were smooth. Collections of granules gathered on downslope rims of the indentations. Refer to photograph 5.

Photograph 5: Round Mark

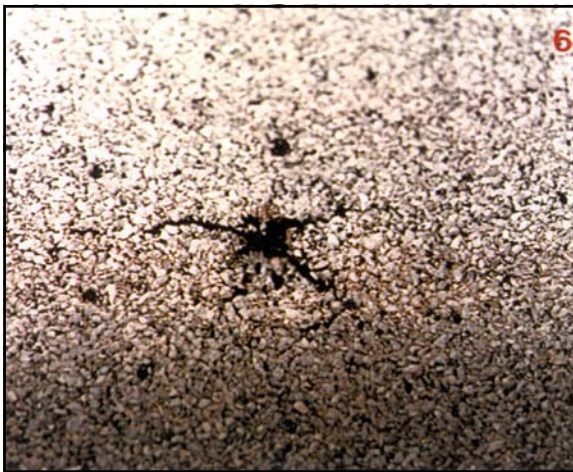
2. *Star-Like Marks* occurred with heavy or moderate blows of the hammers. Cracks radiated outward from the impact point in a star-like pattern. The longest cracks were oriented near parallel to butts of tabs. Indentations recovered slightly in the relatively flexible tabs. Refer to photograph 6.

Photograph 6: Star-like mark

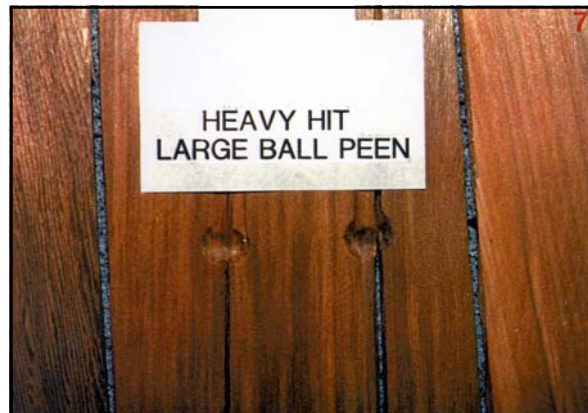
1. With *Heavy Blows*, the ball peen end of all three hammer sizes dented and split the shingles. Wood fibers were compressed most deeply in centers of the impact areas. Shingles split along the grain or were (in some cases) splintered coincident with dents. Refer to Photograph 7.

Photograph 7: Heavy hit, large ball peen

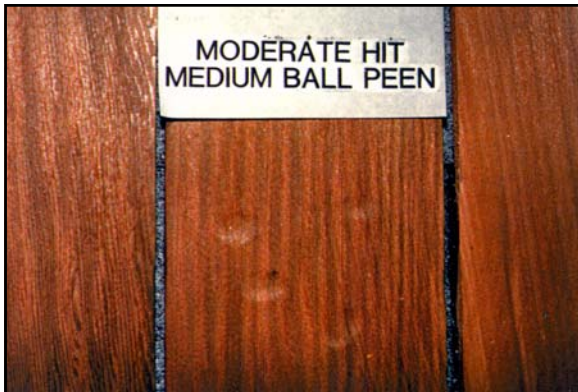
2. *Moderate Blows* dented the shingles but did not split the wood. However, bottom sides of the shingles exhibited splits that did not extend completely to the top (weathering) surface. Refer to Photograph 8.

Photograph 8: Moderate hit, heavy ball peen

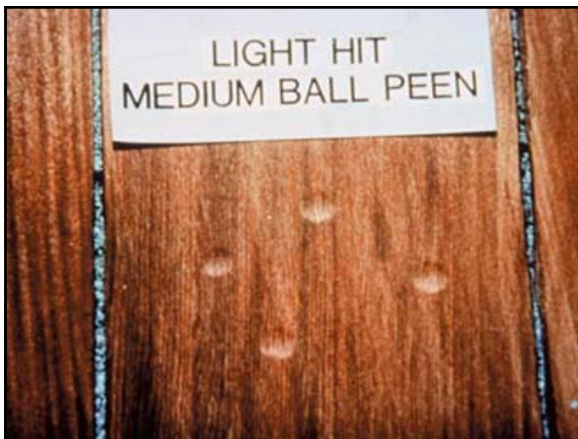
3. *Light Blows* only dented the surfaces of the struck shingles and compressed the wood fibers at the area of impact. No splitting of the shingle occurred. Marks were similar in size and shape, and the wood inside each indentation was compacted similarly. Refer to photograph 9.

Photograph 9: Light hit, medium ball peen
