# LONG-TERM EFFECTS OF HAIL IMPACT ON ASPHALT SHINGLES—AN INTERIM REPORT

**SCOTT J. MORRISON**  
Haag Engineering Co.  
Carrollton, Texas, U.S.A.

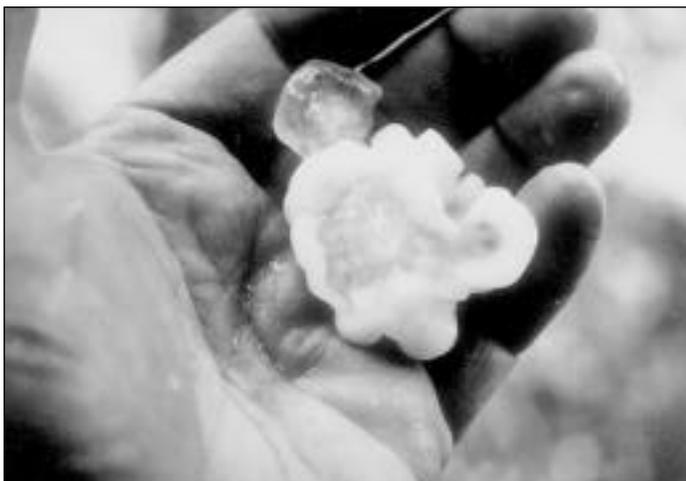
*Photo 1. Naturally occurring hail.*

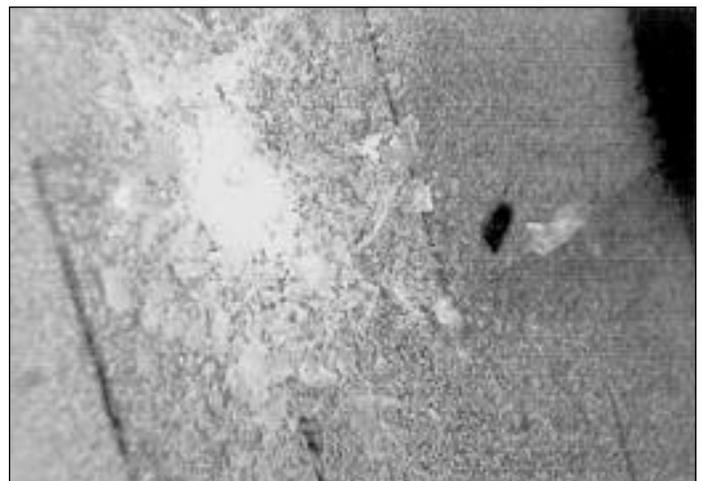
*Photo 2. Shingle impacted by a simulated hailstone.*

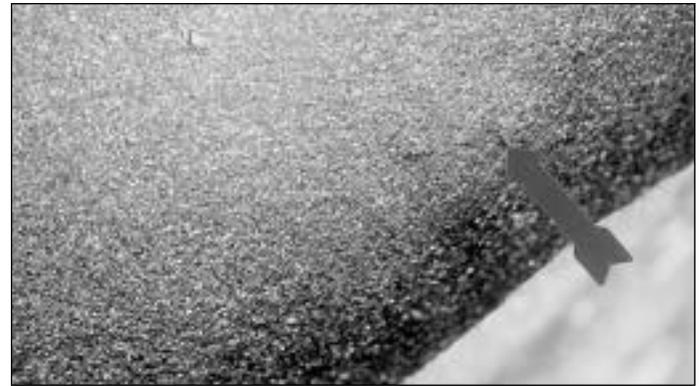
All panels were inspected at approximately 11 years exposure time (Year 11). Additionally, those panels designated originally for impacting at Year 7 were impacted and inspected. Generally, weathering-caused cracks meandered across shingles, with many cracks nearly parallel to butts and some parallel to ends. Some granules had been shed from ends, especially from butts of shingles; some tabs had curled. Examination at sites which were impacted at the initiation of the study but did not fracture at that time showed no identifiable changes in granule coverage. Examination at impact sites with fractures and comparison with photographs taken at 0- and 9-year exposure times showed no visible changes in fracture lengths but did show, in some instances, wider cracks and substantial loss of granules along fracture edges. Here, exposed asphalt was of weathered gray colors, and fracture edges were rounded and tapered. Table 6 lists results of impact testing. See Photos 5, 6 and 7.

Photo 5. Close-up on bottom side of D-7 of half-panel designation CO-TS-D-7 at impact site. Note single-line fracture pattern weathered 4 years 4 months.

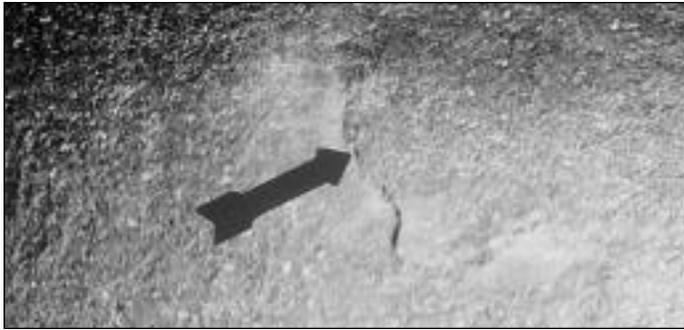
**Photo 6.** Close-up on bottom side of Tab D-4 of half-panel designation CO-FS-D-7 at impact site. Note curved-line fracture pattern weathered 4 years 4 months.

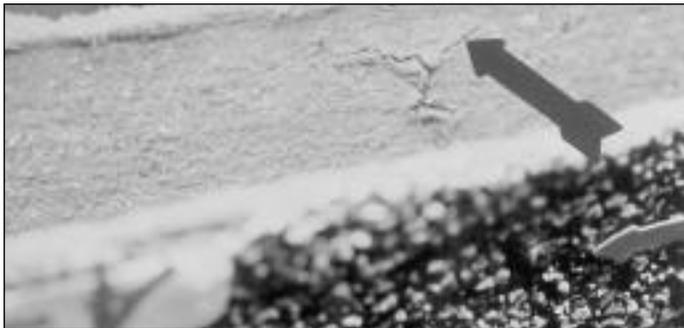
**Photo 7.** Close-up on bottom side of Tab A-5 of half-panel designation CO-WFB-D-7 at impact site. Note multi-line fractures radiating from common point.

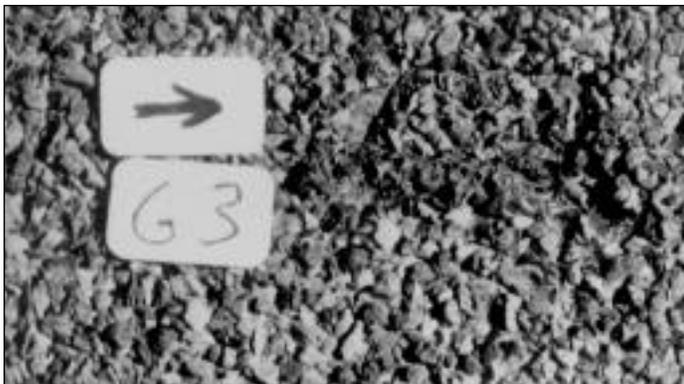
colored asphalt was visible at several locations in the laminated shingles impacted previously. With the blade of a penknife, these areas were probed and scraped carefully. A continuous bed of granules was detected immersed fully in asphalt. The frequency of fractures caused by impacts of 1-inch- (25-mm-) diameter freezer ice balls for all types of shingles tested in this study is presented in Table 7. Typical observations of an impact site with fractures are depicted at 10 years 6 months and 14 years 11 months in Photos 8 and 9, respectively. Photo 10 depicts asphalt underlaid with granules.

**Photo 8.** Close-up of Tab G-3, half-panel designation CO-FS-D-0 at 10 years 6 months weathering exposure. Note impact-caused fracture.

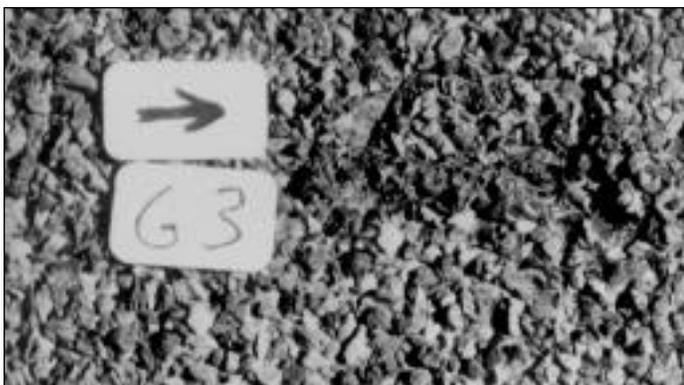
**Photo 9.** Close-up of Tab G-3, half-panel designation CO-FS-D-0 at 14 years 11 months weathering exposure. Note impact-caused fracture.

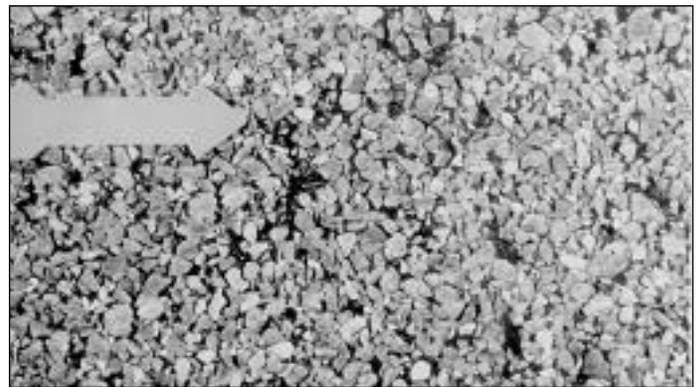
**Photo 10.** Close-up of D-2 of half-panel designation CO-TS-D-0 at 14 years 11 months weathering exposure. Note that granules were detected below the asphalt in vicinity of arrow.

- Some impacts made with freezer ice on laminated shingles dislodged granules from exposures without exposing asphalt. Granules subsequently were shed at impact locations over time with natural weathering. Careful examination at these locations revealed a continuous bed of granules immersed in the asphalt. There was no reduction in the expected service life of the shingles as granules on the shingles continued to protect the underlying asphalt and reinforcement. The condition was not functional damage but merely a cosmetic condition.

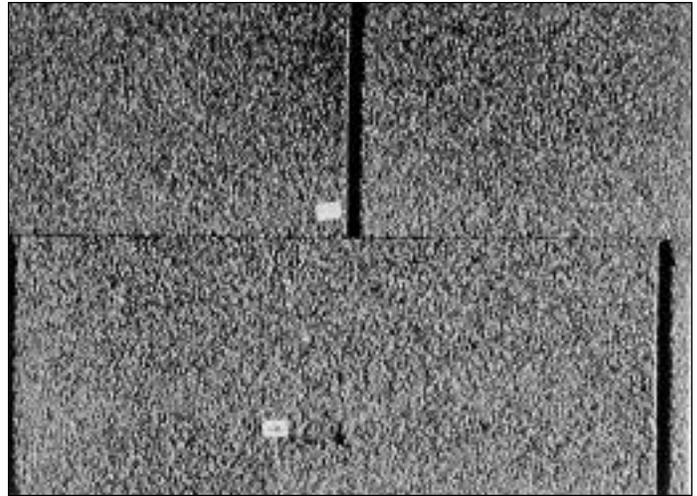
**Photo A3.** Close-up at Tab G-3 at 10 years 6 months weathering exposure. Note fracture.

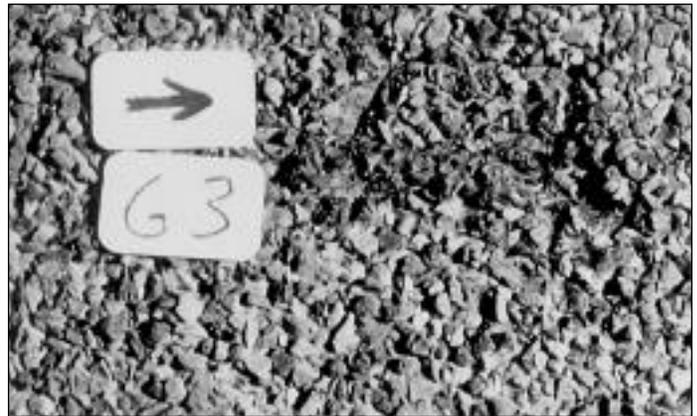
**Photo A4.** Close-up at fracture in Photo A3.

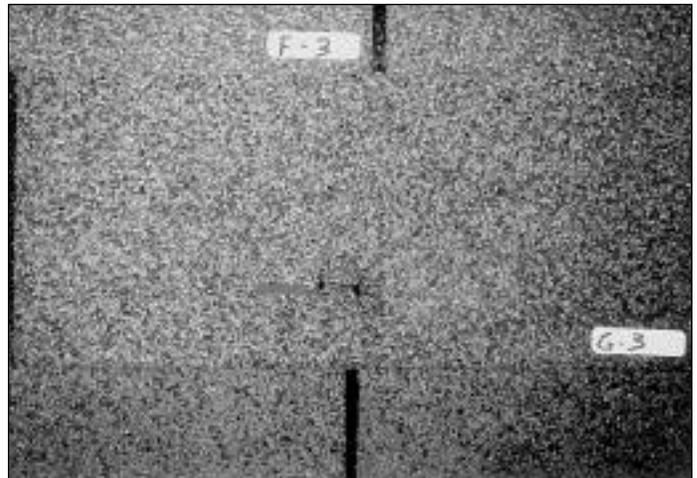
**Photo A5.** Close-up of Tab G-3 at 14 years 11 months weathering exposure. Note impact-caused fracture.

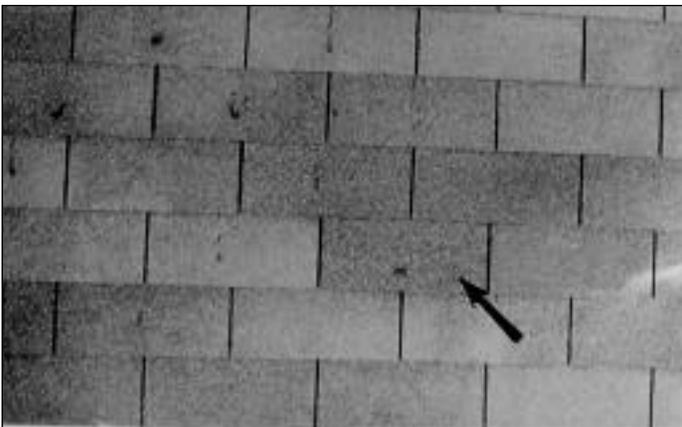
**Photo A2.** View of test panel at Year 0 after impacting. Note fracture in Tab G-3.

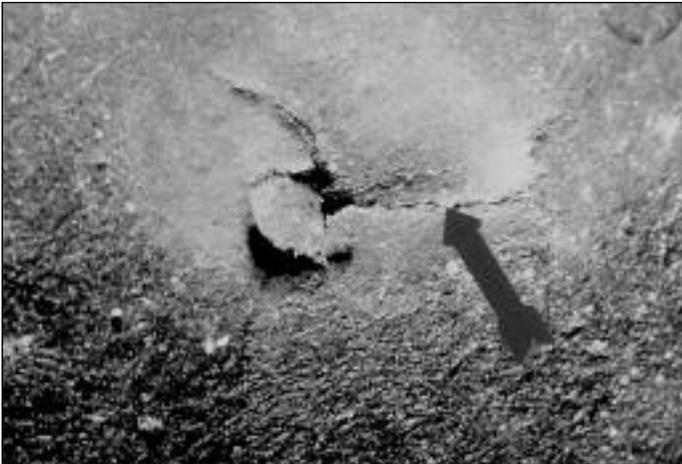
*Photo A7. Close-up on bottom side of Tab G-3 at area depicted in Photo A6.*

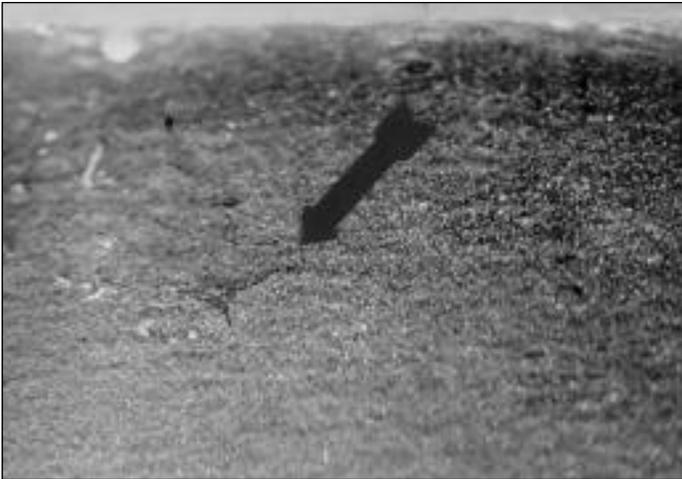
**Photo C6.** Close-up on bottom side of Tab C-5 at area depicted in Photo C5. Note fracture.

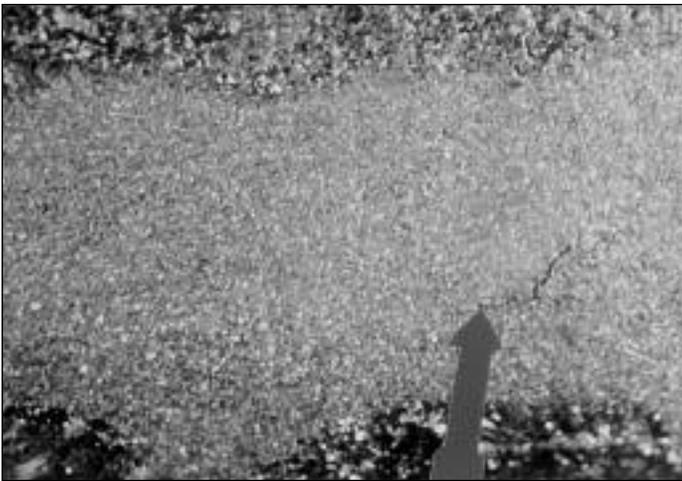
*Photo D6. Close-up on bottom side of D-10 at location depicted in Photo D5. Note fracture.*
