Testing of Impact-Resistant Asphalt Shingles

By Steven R. Smith, PE;
Timothy P. Marshall, PE;
and Jonathan S. Goode, PhD, PE

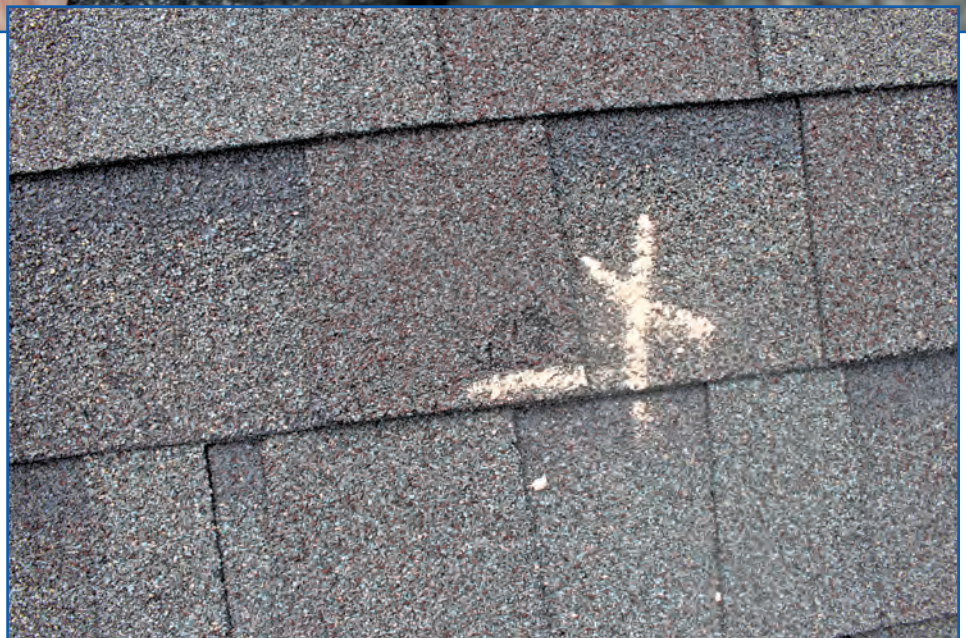
Figure 1 – Example of a hail-caused bruise looking down at the top of an asphalt shingle.

Hail damage to roofing is generally understood as a condition caused by hail that either reduces the water-shedding capability or the remaining service life of the roofing material.^{[4],[5],[6]} These criteria do not address cosmetic effects, which are beyond the scope of this paper. Regarding asphalt shingles, hail-caused damage is typically a rupture in the mat material (reinforcement). Hail-caused ruptures in asphalt shingles are often described using other terms, including fractures, tears, or bruises. These terms are synonymous when discussing hail-caused damage and should not be confused as separate conditions. The term “bruise” came about because once the reinforcement is compromised by a hail impact, a relatively soft spot (similar to a soft bruise in an apple) can be felt manually during a roof inspection. Bruises in shingles not only can be felt by tactile examination, but they can also be observed visually on the bottom sides of shingles. Even slight bruises can allow water seepage and, over time, can lead to premature weathering at the bruise. Consequently, hail-caused bruises in shingles are considered damage because they compromise the ability of the shingle to shed water. A hail-caused bruise viewed on the top of an asphalt shingle is depicted in *Figure 1* and the bottom of the same shingle at the bruise in *Figure 2*.

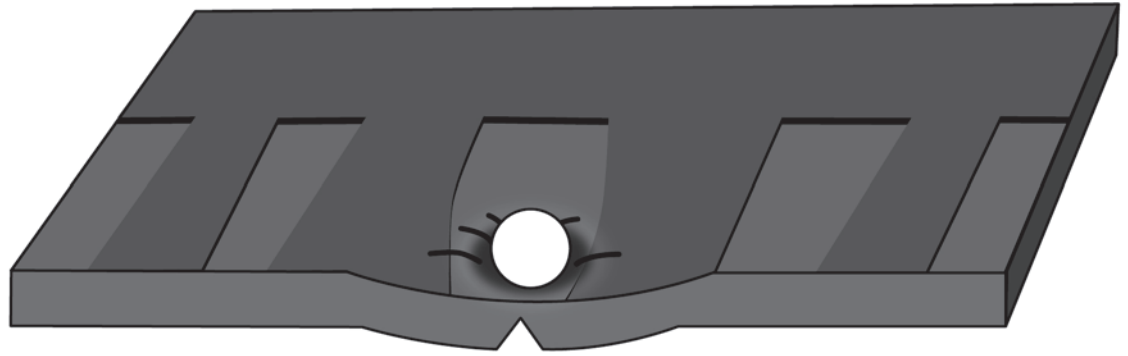
Figure 3 – Illustration depicting the formation of a hail-caused bruise/fracture in an asphalt shingle.

bottom sides of shingles because the shingles flex on impact. The flexure imparts a tensile stress on the bottom of the shingle, which can tear the reinforcement. Because most of the shingle strength is provided by the reinforcement, a bruise in a shingle means the reinforcement is fractured or substantially strained. *Figure 3* illustrates a hailstone impacting a shingle, causing a bruise/fracture.

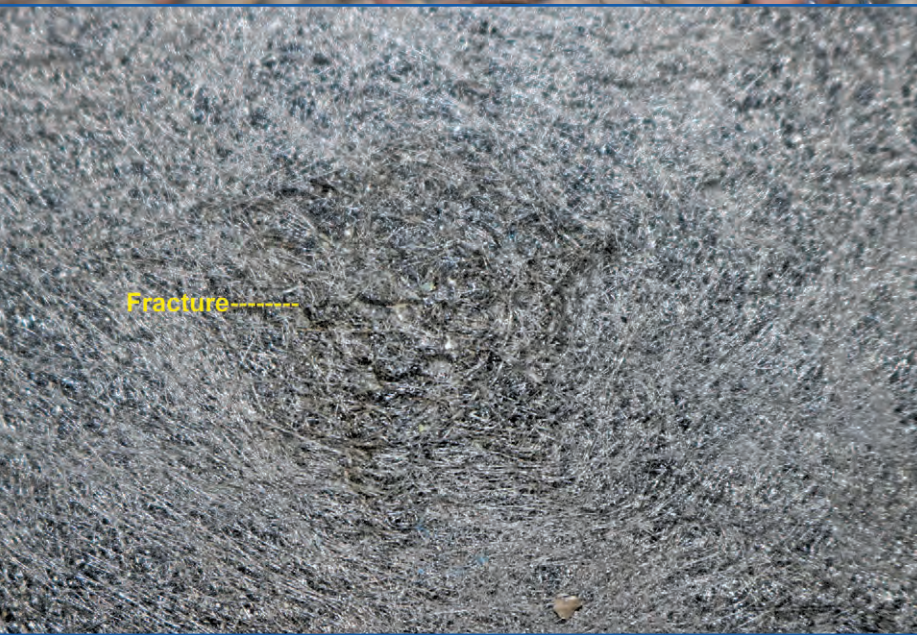
Figure 7 – UL-2218 Class 4 double impact. Note crushed granules on top of the shingle.

Figures 7 through 10 depict a Class 4 shingle after a set of Class 4 UL-2218 tests. Recall that the test procedure requires double impacts. Note the crushed granules are a cosmetic condition of the testing and are not considered in the test results. Any fracture visible on the bottom of the shingle constitutes a test failure; however, many of the

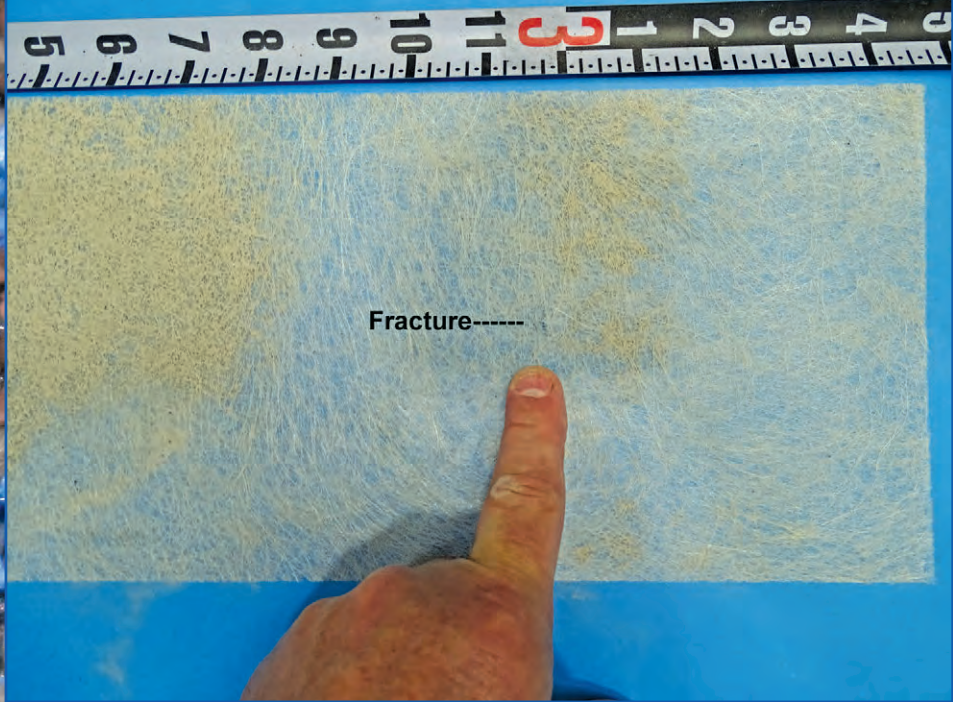
Figure 9 – Desaturated shingle pointing to the impact location.

shingles exhibited conditions that appeared to be fractures but could not be visually confirmed. Desaturation of the shingle revealed a fracture in the reinforcement, which would constitute hail damage in field inspection/evaluation.

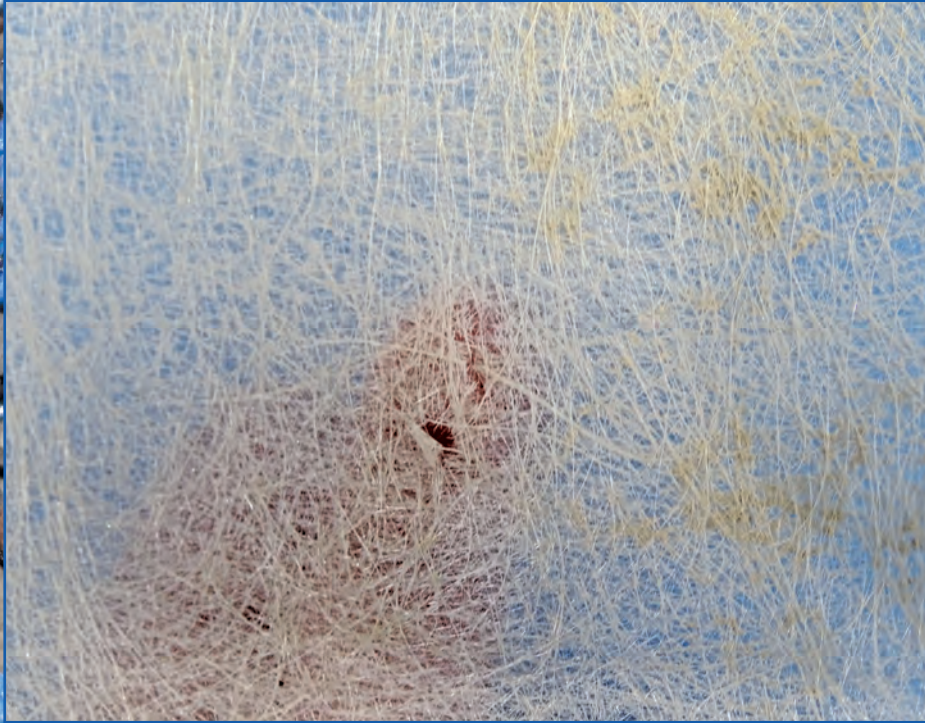
Figure 10 – Close-up of the fracture in reinforcement at the impact location.

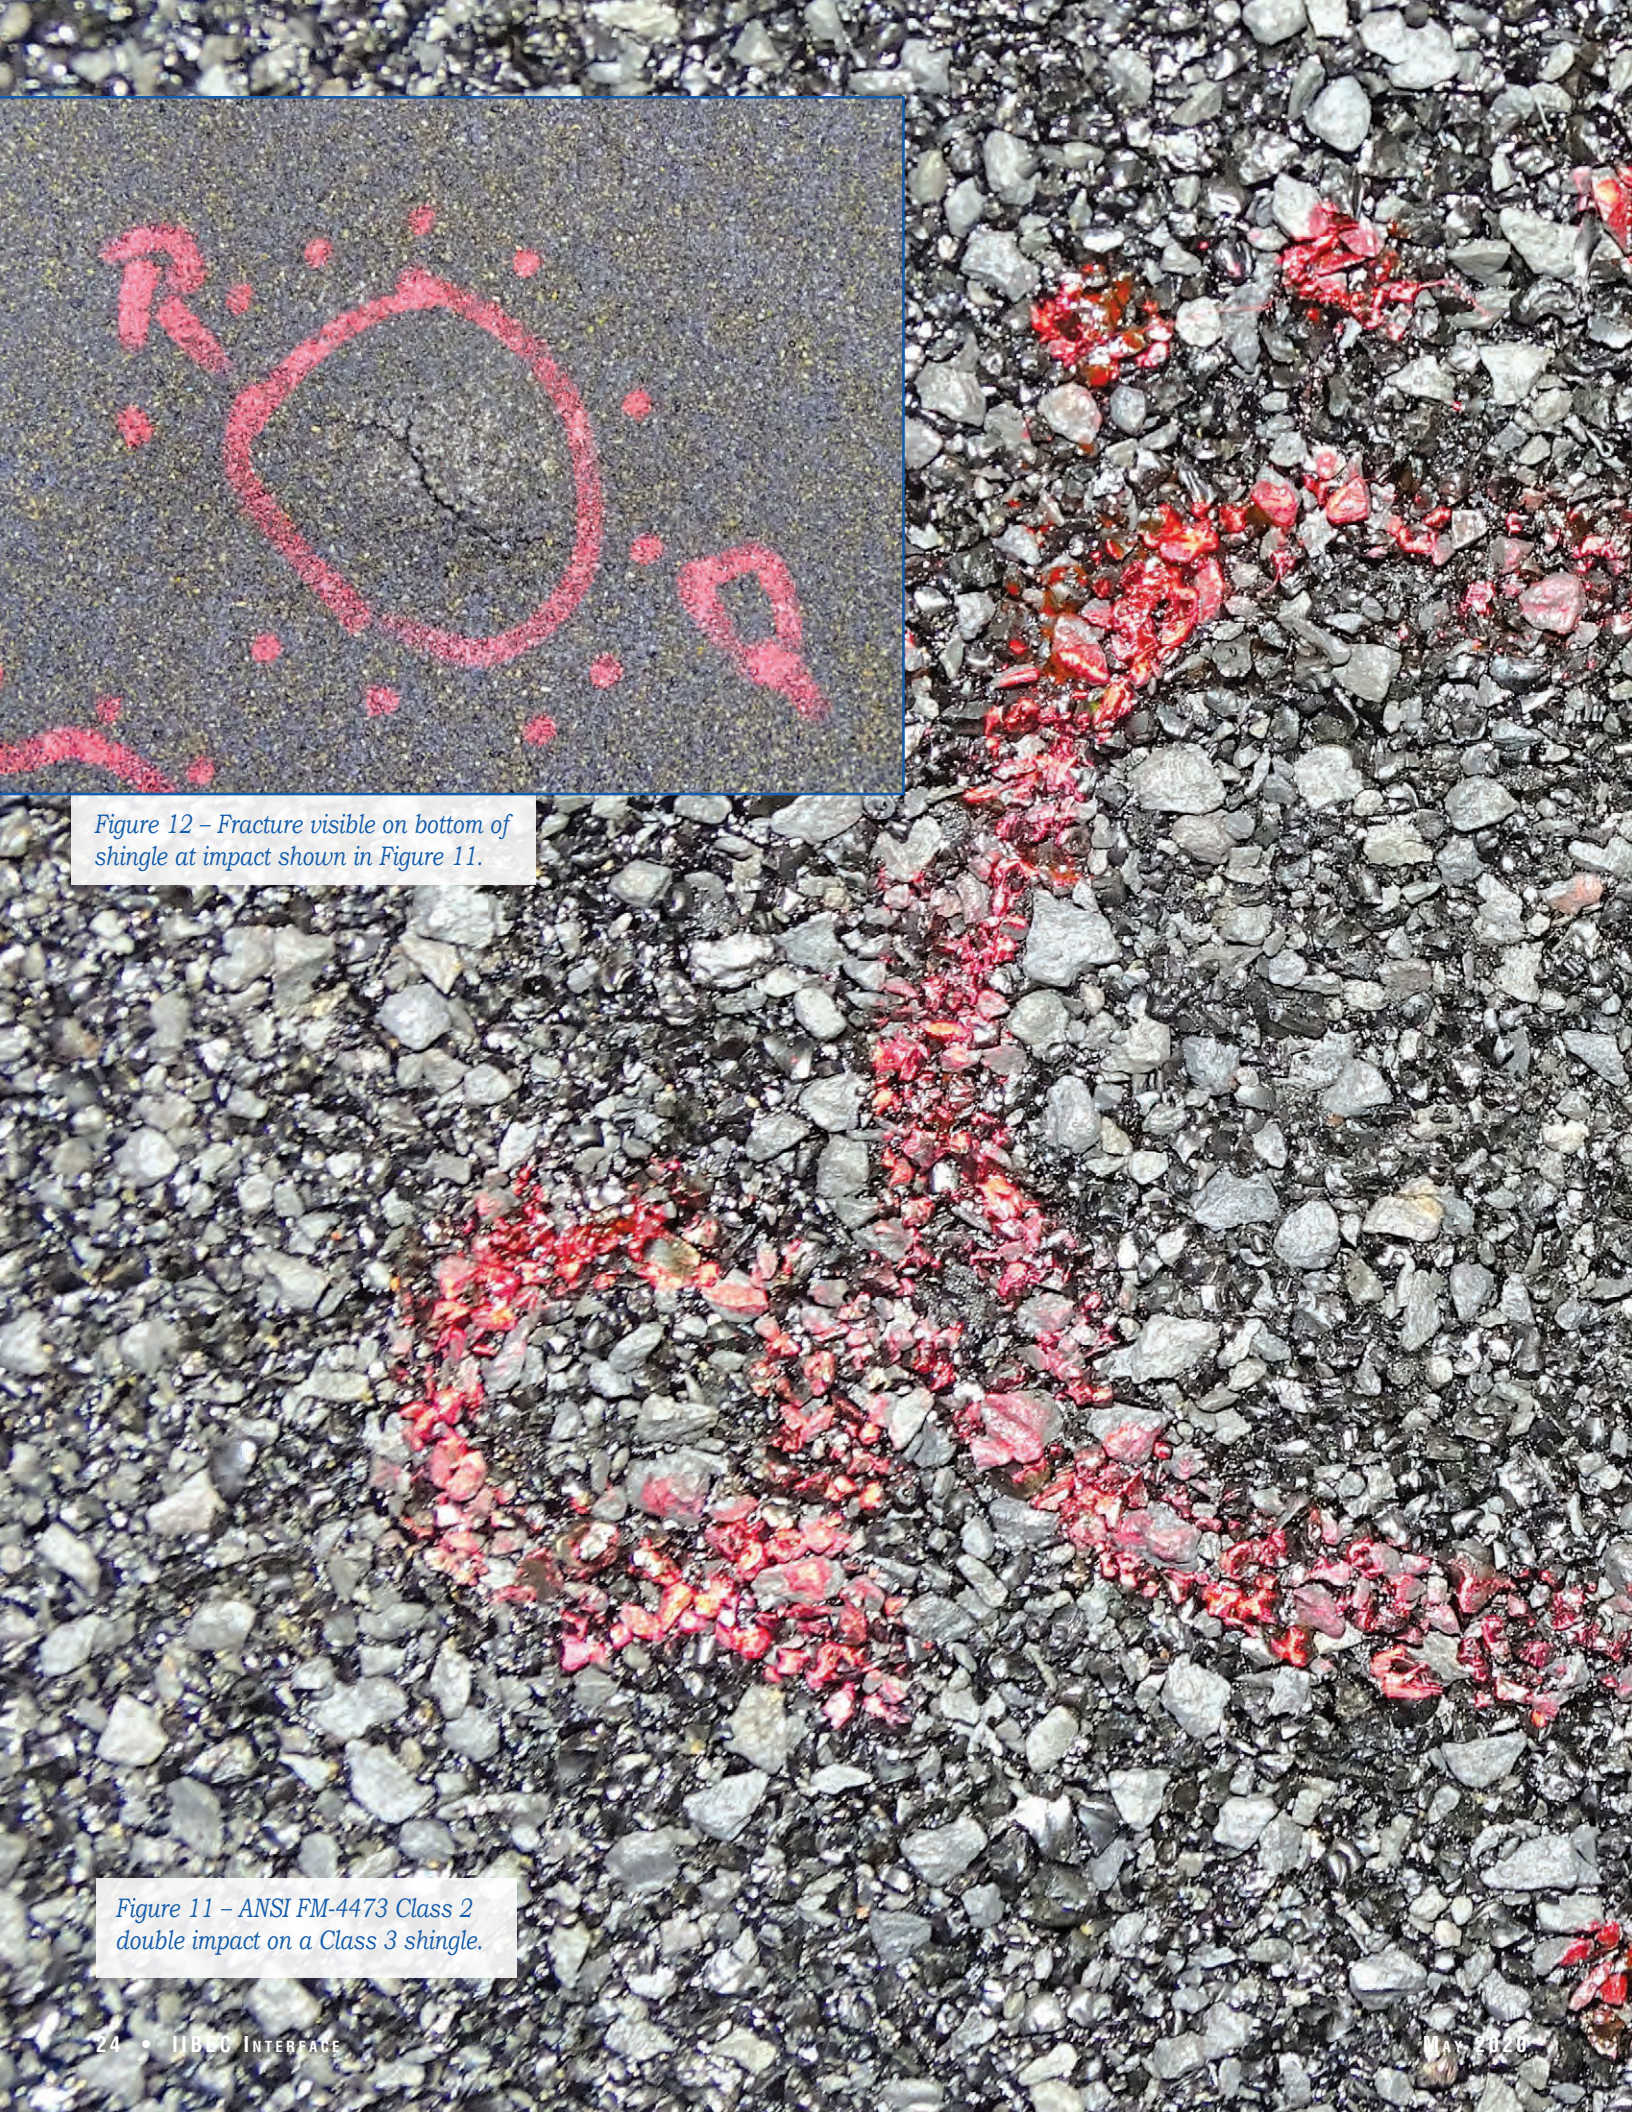
Figure 11 – ANSI FM-4473 Class 2 double impact on a Class 3 shingle.

Figures 11 through 14 depict the Class 3 shingle after a set of Class 2 double impacts per the ANSI FM-4473 standard. Note the granules did not crush, but a clear fracture was detected on the bottom side of the shingle. Desaturation of the shingle revealed a fracture in the reinforcement at the impact location.

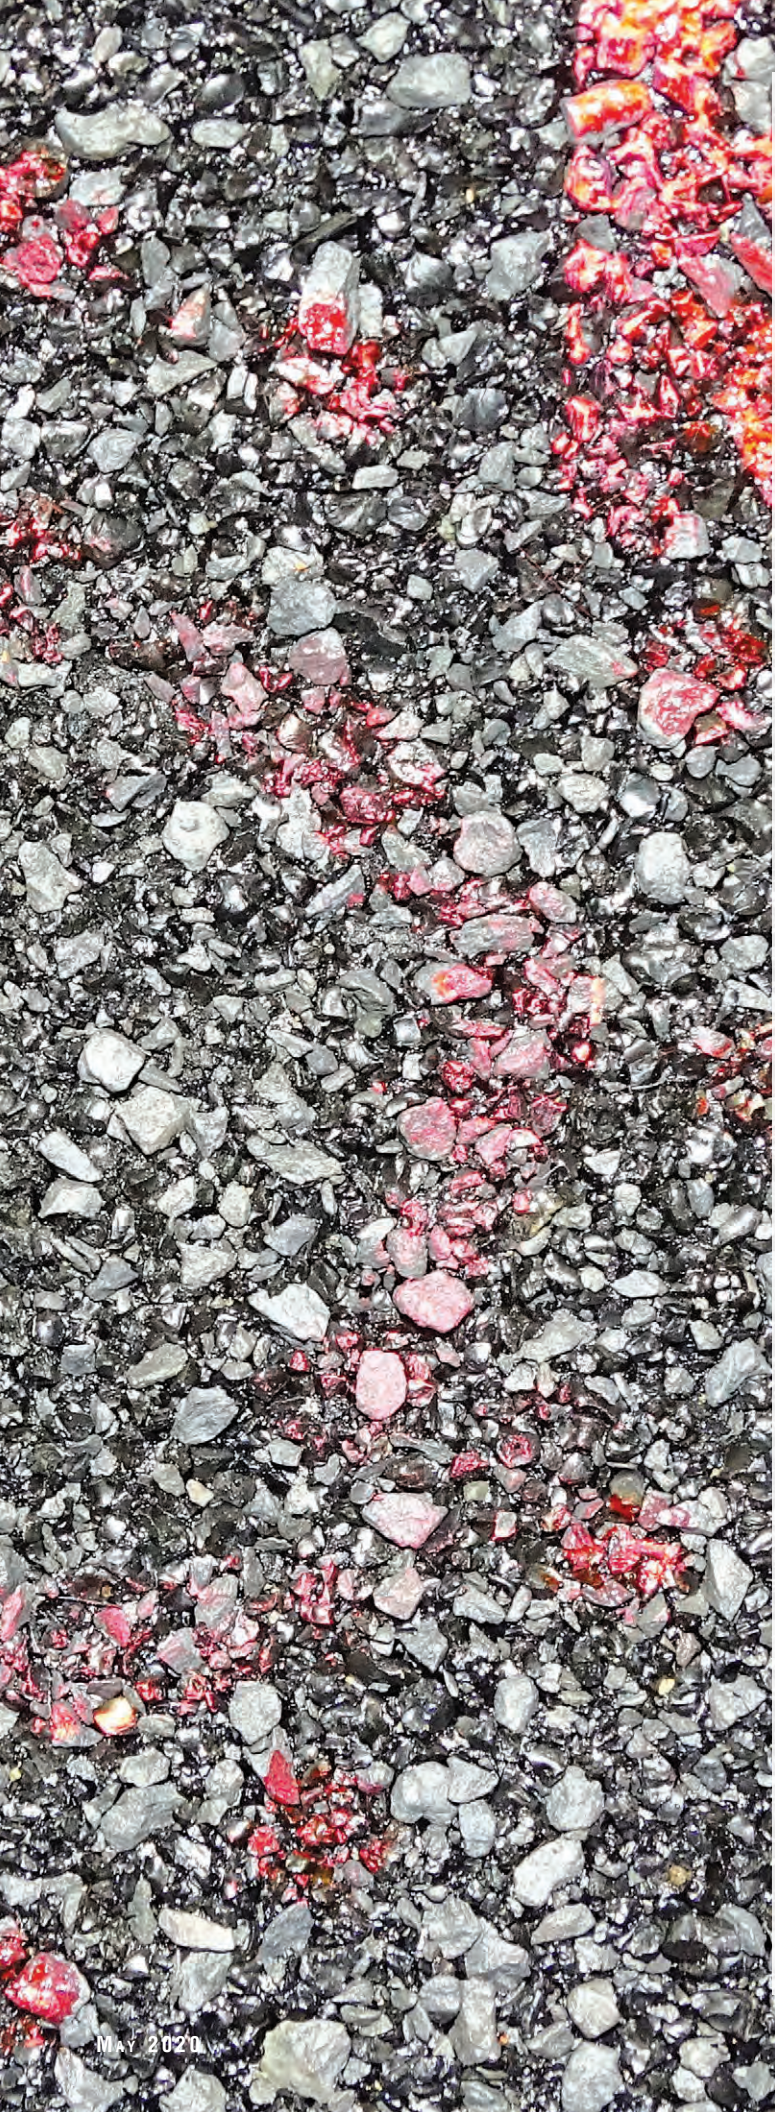
Figure 12 – Fracture visible on bottom of shingle at impact shown in Figure 11.

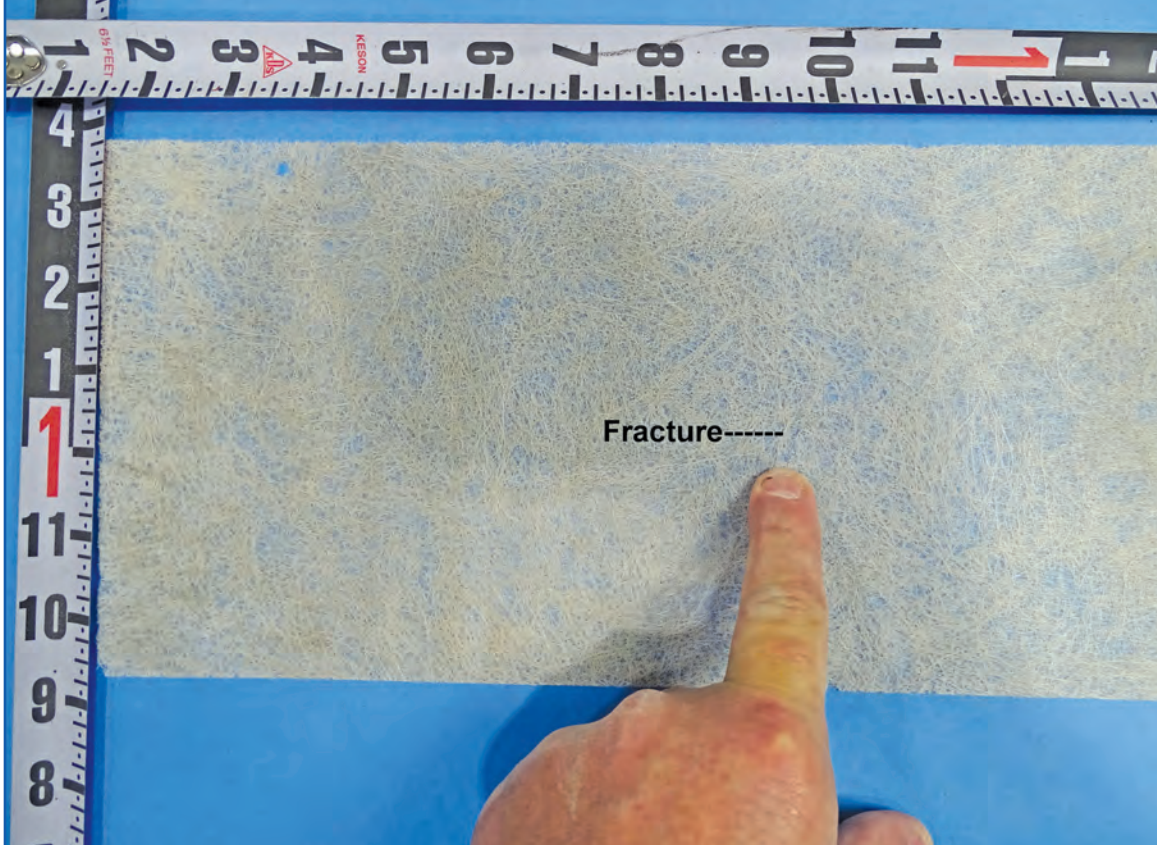
Figure 13 – Desaturated Class 3 shingle showing fractured reinforcement.

Based on the results of this testing, we recommend the UL-2218 and ANSI FM-4473 test standards be modified to include solvent extraction of reinforcements when testing asphalt shingles to absolutely determine whether the products have been damaged during testing. This step would prevent asphalt shingles from appearing more hail-impact-resistant than they actually are.

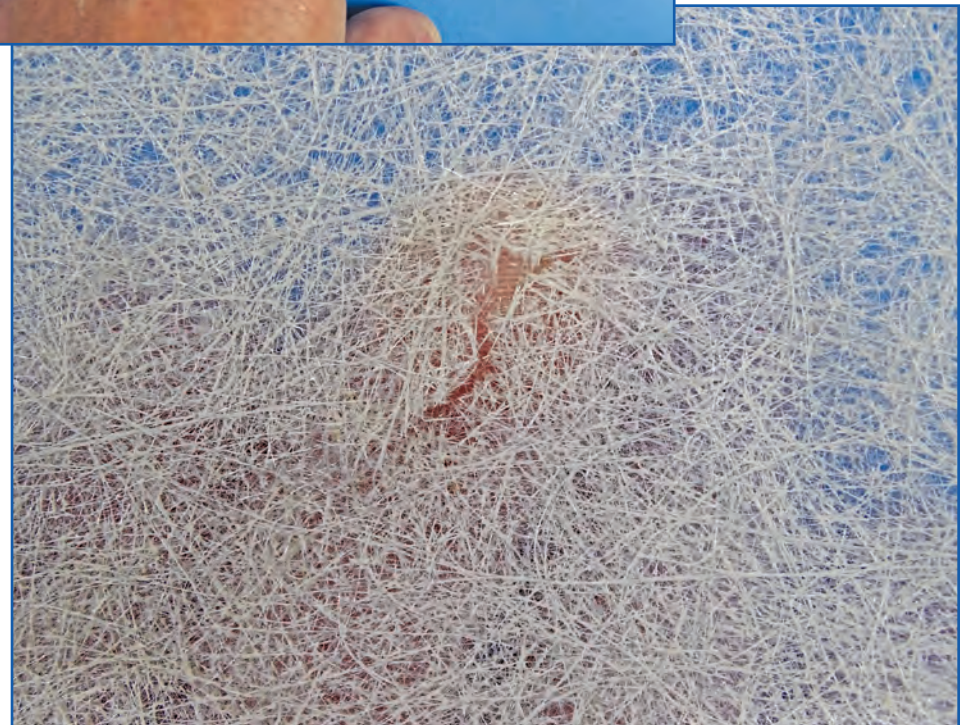
Figure 14 – Close-up of fracture in reinforcement shown in Figure 13.
