Ice Ball Impact Testing of Roofing Materials

T. Marshall, S. Morrison, R. Herzog, J. Spruiell, and J. Green
Haag Engineering Co., Irving, Texas USA

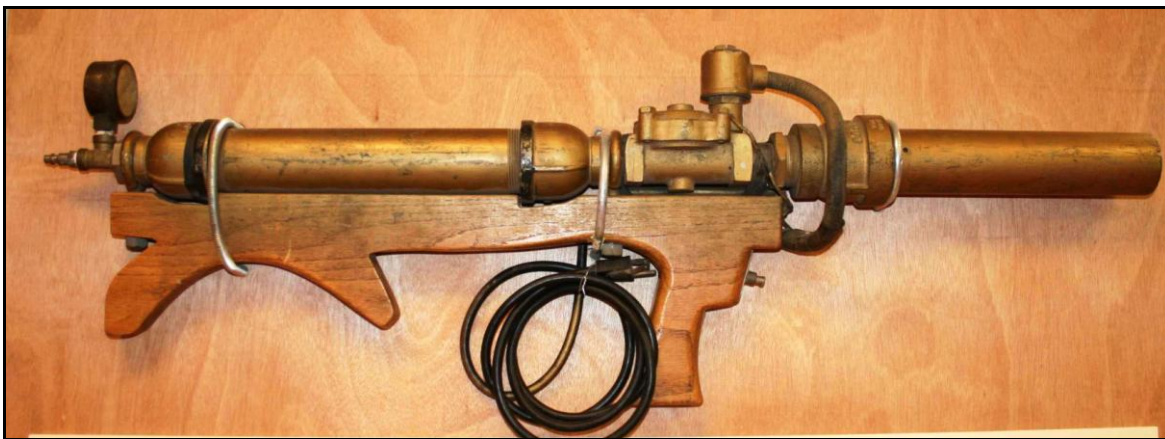
Figure 1. First ice ball launcher (IBL-1) constructed by Haag Engineering Co. in 1963 for their impact study on cedar shingles.

Haag Engineering Company began a testing program in 1963 launching ice stones at various grades of new cedar shingles [4]. Eighteen test panels were constructed in 1.2 m squares. Every shingle on fifteen panels was struck with 25 mm spherical or 38 mm cubical ice stones propelled by a shoulder mounted air gun made from steel pipe. Air pressure within the barrel of the gun was regulated and had a quick release valve (Figure 1). The remaining three panels were not impacted and used as a control for the experiment. All 18 test panels were set outdoors to weather naturally for 20 years and examined periodically. Damage was defined as a split in the wood shingles. The study found that splits shingles occurred at the moment of impact and that dents in the wood without initial splitting did not cause future splitting or other deterioration. Dents in the wood were found to recover or erode with time.

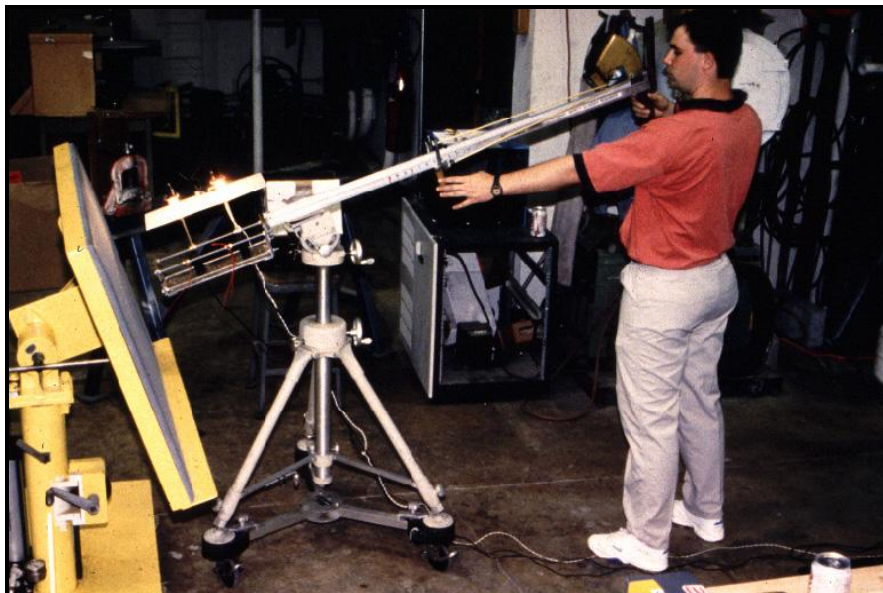
Figure 2. Third generation ice ball launcher (IBL-3) constructed by Haag Engineering Co. for their 1983 impact study. A chronograph was mounted to the end of the launcher to measure the velocities of the ice balls.

Haag Engineering's test program was expanded in 1983 to include asphalt shingles, fire-retardant treated wood shingles and shakes, wood fiberboard panels, and aluminum panels [6]. A new ice ball launcher, similar to a spear gun, was designed and fabricated (Figure 2). Elastic tubing was secured to each end of a crossbar that was oriented perpendicular to length of the launcher. The crossbar could be adjusted to different positions along the length of the launcher to allow adjustment of the rubber tubing when the launcher was cocked. Stored energy, and thus the ice ball velocity, was proportional to the amount of tubing stretched. Ice balls rode in a carrier made to fit an aluminum rail that ran the length of the launcher. A locking mechanism at the rear end of the launcher secured the carrier that could be released via a trigger. When the trigger was depressed, the carrier released and accelerated forward, propelled by the contracting rubber tubing. Then as the carrier neared the end of the launcher, it decelerated, allowing the ice ball to travel forward unimpeded. A chronograph fixed to the front end of the gun measured the speed of the airborne ice ball. Ice balls were made using rubber molds and varied from 25 to 32 mm in diameter. Damage to cedar shingles and shakes involved splitting the wood whereas wood fiberboard panels were merely dented with no long-term damage noted. Aluminum panels were dented but the dents were merely cosmetic. From this work, Marshall and Herzog published a protocol on how to properly evaluate hail-caused damage to roofing [7].

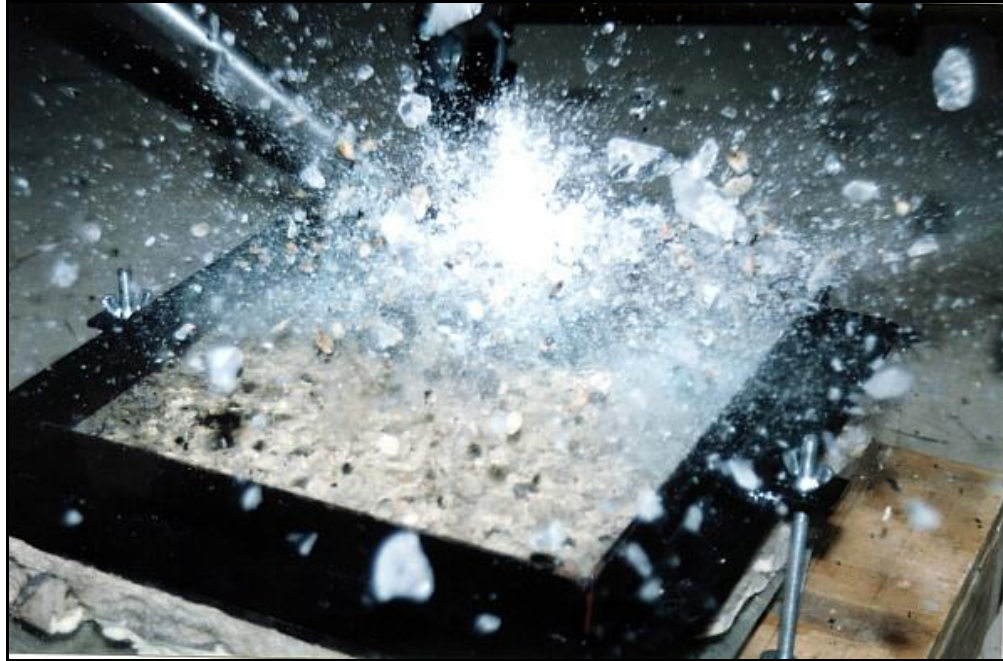
Figure 4. Ice ball breaks apart upon impact removing some of the surface gravel and flood coat on a built-up roof. No damage was done to the underlying roofing plies.

A total of 94 impacts were made against the built-up roof samples: 76 ballasted with gravel and 18 with both loose and embedded gravel removed prior to testing. For the samples with gravel ballast, the ice ball typically broke apart or shattered upon impact, displacing the loose gravel and forming a divot (crater) in the loose gravel (Figure 4). Larger and faster ice balls created larger and deeper divots in the loose gravel. The largest ice ball impacts removed pieces of the asphalt flood coat, leaving the exposed asphalt surface fragmented and shiny. In no instance was gravel driven downward into the roofing membranes.

Examination of impact zones on roofing samples covered with gravel revealed no impact damage using either 51 mm diameter balls or 40 mm wide cubes. This result was independent of the base material used (poured gypsum concrete, concrete block, or expanded polystyrene insulation). Similarly, no impact damage occurred to roofing samples where all the gravel had been removed (spudded) and placed on top of a poured gypsum deck. However, one of the three impacts by 51 mm diameter ice balls did cause a slight indentation and tear in the top ply of the spudded sample resting on a concrete block base. Similarly, one of three impacts produced by the 40 mm cubical ice stones damaged the spudded sample supported by 51 mm expanded polystyrene insulation. Tears occurred in all plies. Finally, all three impacts of the 51 mm ice balls damaged the spudded samples resting atop expanded polystyrene insulation. This confirmed Greenfeld's observation that softer substrates make the overlying built-up roof more susceptible to impact damage. Also, like Greenfeld's study, our test results indicated that gravel surfacing provided significant impact protection to the built-up membranes.

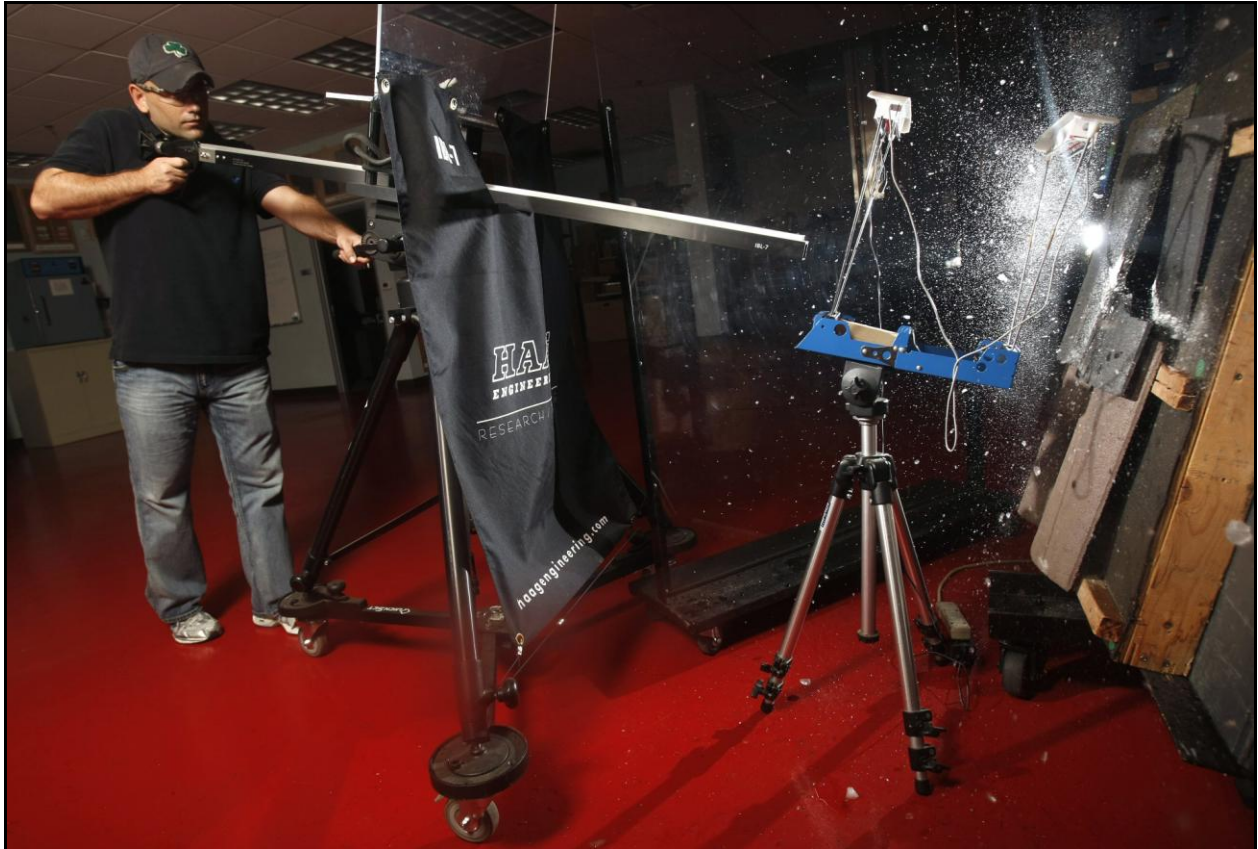
Figure 5. Seventh generation ice ball launcher (IBL-7) with light emitting diode (LED) sensors (chronograph) developed for impact testing.

The current ice ball launcher utilized at Haag Engineering includes improvements in design such as attachments for multiple elastic tubing and plastic sleds which can propel ice balls from 13 to 57 mm in diameter (Figure 5). An adjustable laser is mounted on top of the launcher to reveal the location of the impact on the target. Plastic and fabric safety shields are mounted on the launcher to provide protection from ricocheting ice balls. Solid ice balls are made in silicone molds (Figure 6).
