MISCONCEPTIONS OF WIND DAMAGE TO ASPHALT COMPOSITION SHINGLES

BY CARLOS R. LOPEZ, PHD, PE;
JONATHAN S. GOODE, PHD, PE;
AND SCOTT R. MORRISON, PE

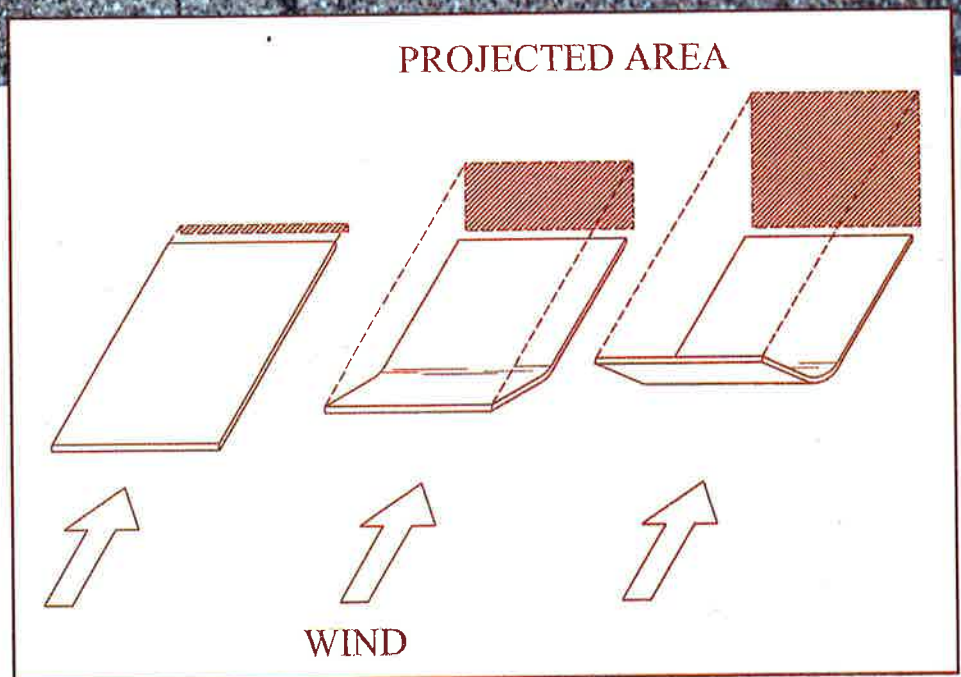
Figure 1 - Relative increase in projected area (hatched box) as shingle is lifted by the wind. As a shingle tab rises in the wind, more surface area is exposed and, thus, a stronger force occurs.

factory-applied adhesive fails. As the shingle rises in the wind, more surface area is exposed to the wind and, thus, a greater uplift force occurs. Refer to *Figure 1*.

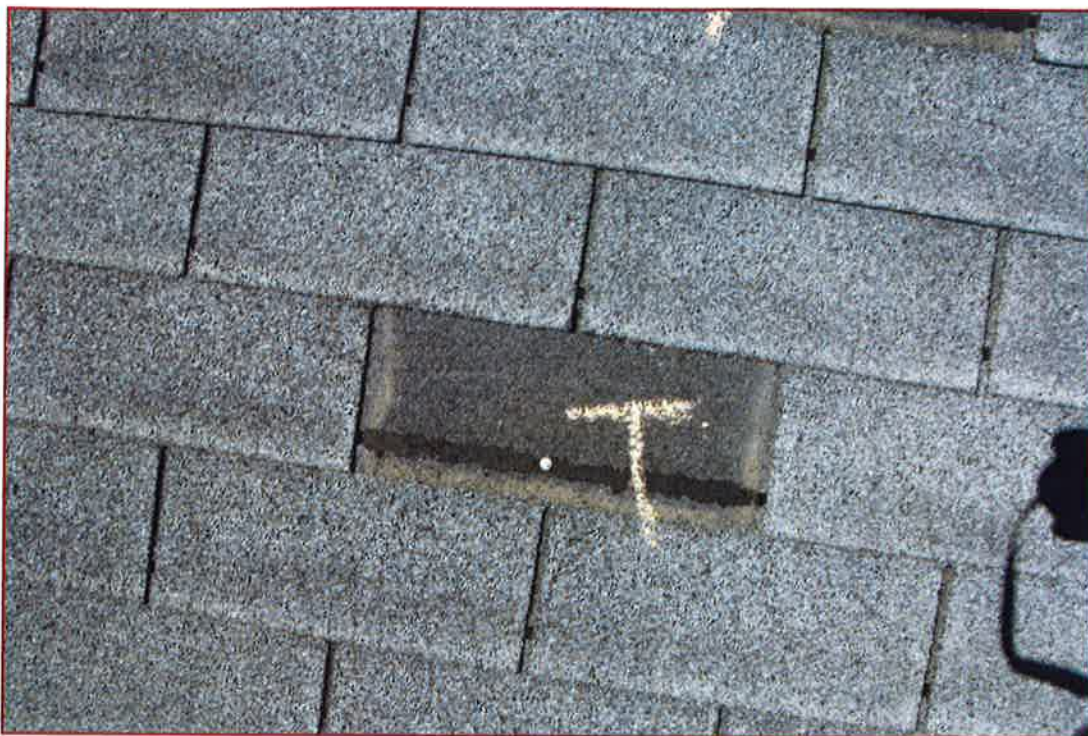
Figure 3 - Torn shingle tab.

This progression will tend to flip and crease or tear the shingle. The wind forces cause the shingle to flutter and bend such that further creases may develop (*Figure 2*). Eventually, if the wind force is strong enough, the tabs or shingle sections break off and are carried downwind (*Figure 3*). This is particularly the case in areas of the roof that are exposed to higher wind forces (e.g., eaves, hips, ridges, etc.). Failure typically occurs at the top of the exposed section, just below the butt end of the overlying shingle.

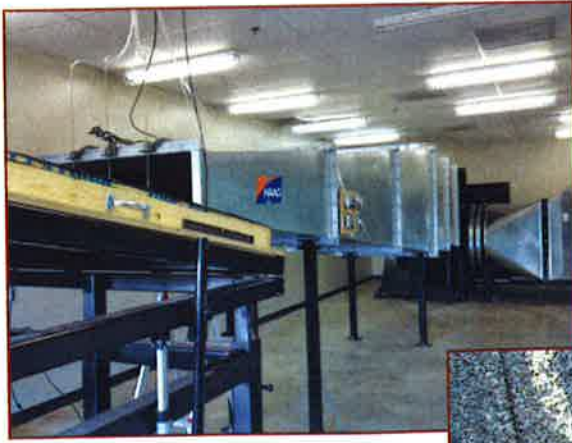
Figure 4 – Haag wind simulator.

A recently completed test performed by Haag Research/Testing (HRT) documented the mechanisms by which shingles are damaged by wind. HRT employed a wind simulator (*Figure 4*) capable of producing wind speeds up to 175 mph and compliant with ASTM D3161, *Standard Test Method for Wind-Resistance of Steep Slope Roofing Products (Fan-Induced Method)*. Post-test inspection of all shingles that unbonded during the testing revealed that, at a minimum, creases were present. Shingles utilized in this test were not weathered, but were placed on the test assembly days before the test. In the new, pliable shingles tested, the creases required very close inspection and tactile manipulation (i.e., placing hand pressure from underneath the shingle) of the granular surface to observe the crease; nonetheless, they were present and observable.

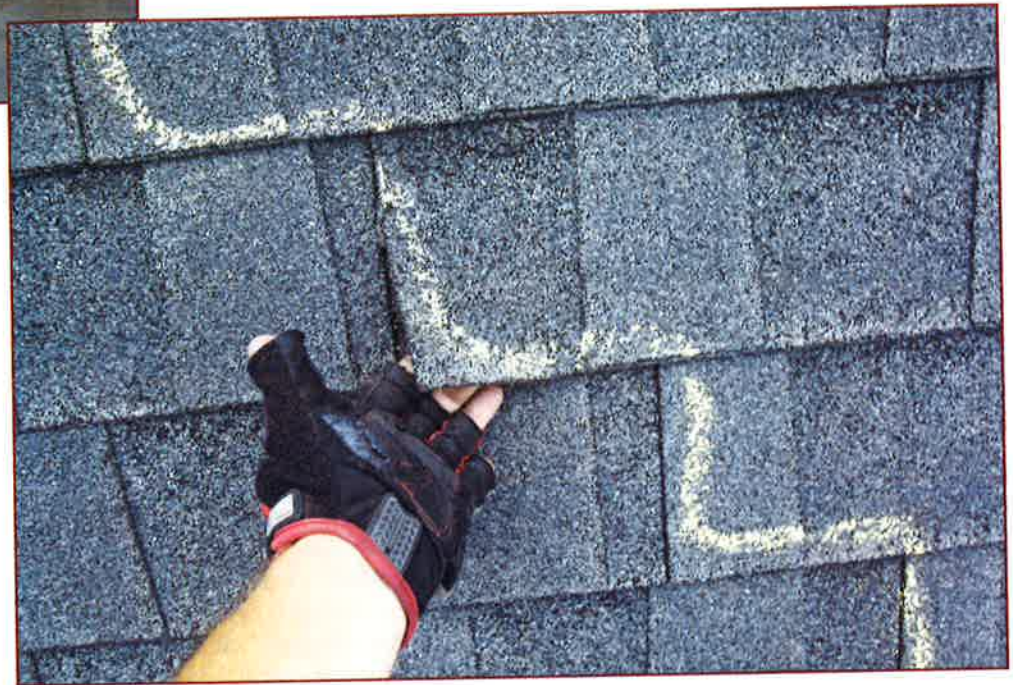
Figure 5 – Unbonded diagonal pattern of shingle overlaps.

Cyclic thermal expansion and contraction, for example, will yield a pattern of unbonded shingle overlaps extending up-slope diagonally, reflecting the pattern in which these shingles were installed (*Figure 5*). A similar pattern is often observed with shingles installed in a straight-up pattern, referred to as "racked." An unbonded pattern of shingle tabs in a racked installation is commonly referred to as zippering (chalk lines in *Figure 6* show the nonbonded shin-

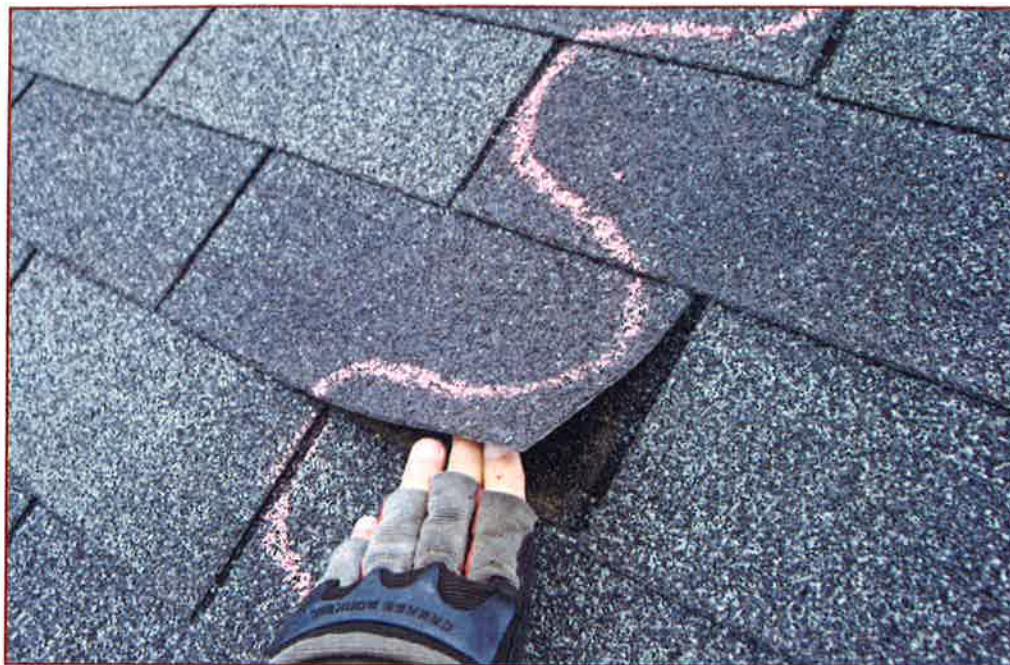
Figure 6 – Unbonded raked pattern of shingle overlaps.

gle portions). These unbonded overlaps will not vary in direction or increase/decrease in areas of the roof where wind uplift would
