PROCEDURE FOR ASSESSING WIND DAMAGE TO WOOD-FRAMED RESIDENCES

Timothy P. Marshall*
Haag Engineering Co.

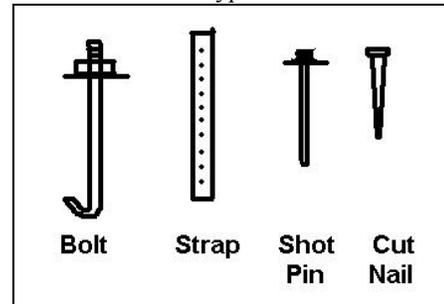
Figure 1. Common types of foundation fasteners.

Homes on concrete slab foundations usually are bolted or strapped to their foundations. However, some municipalities have adopted variances in the building codes that allow shot pins or cut nails. Figure 1 shows common types of foundation anchors.

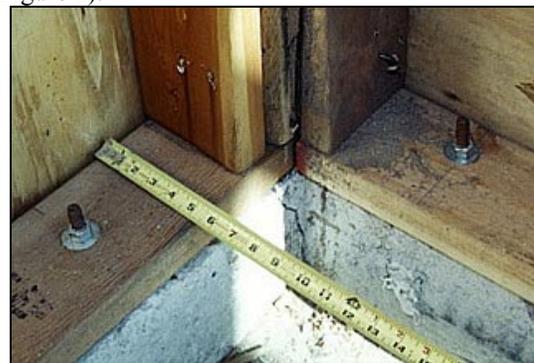
Figure 2. Properly bolted bottom plate. However, note the weak straight-nailed connection between the wall studs and bottom plates.

Anchor bolts are at least 1.3 cm (1/2 inch) in diameter and 30 cm (12 inches) long and have a J-shaped profile that provides significant pull-out resistance. The anchor bolt is inserted into the concrete slab while it is poured with a depth of at least seven inches and must have sufficient height above the slab to pass through the plate and accept a steel nut and washer. Anchor bolts are spaced 1 to 2 meters (3 to 6 feet) apart and located within 30 cm (12 inches) of the end of the plate and wall corners (Figure 2).

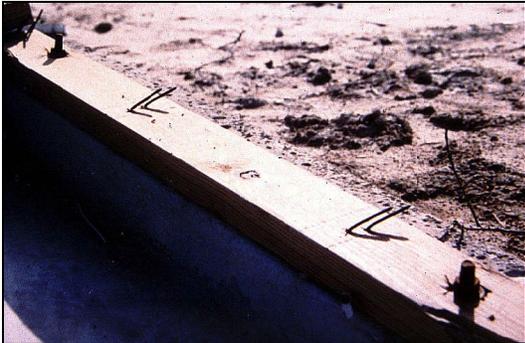
Figure 3. Failure of this home occurred where the wall stud was nailed to the bottom plate.

washers. A properly anchored sill or bottom plate is a strong connection and rarely fails. Instead, failure of the home is more likely where the wall stud is nailed to the bottom plate (Figure 3). Therefore, homes that are bolted down to their foundations are not necessarily well-built or wind resistant.

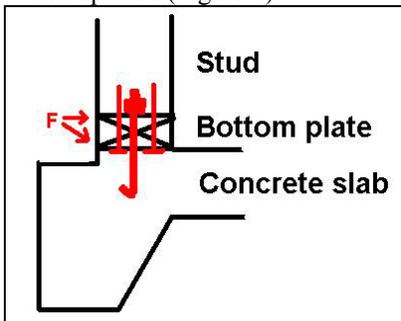
Figure 4. Typical wall cross section on concrete slab foundation showing a bottom plate bolted to the foundation and straight-nailed into the wall stud. Connections and failure points ("F") are in red.

The bottom plate is either straight-nailed into the wall stud and/or the wall stud is toenailed into the bottom plate (Figure 4). A pair of 16d (8.9 cm or 3.5 in) common nails often are used for this connection. Although such a connection will meet the minimum requirements in most building codes, it is inherently weak when uplifted (Figure 4).

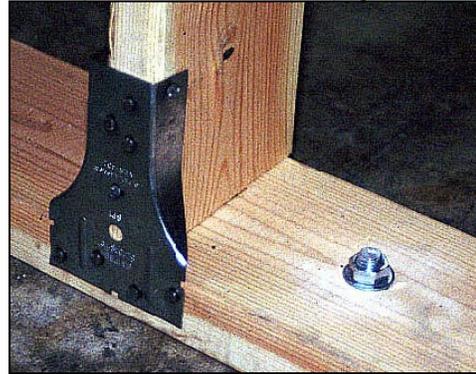
Figure 5. A metal clip connecting the wall stud to the bottom plate provides considerably more uplift resistance than conventional straight- or toe- nailing.

Marshall (1983) conducted pull tests on pairs of 16d nails that connected plates to studs. For straight-nailed connections, the average pull-out strength was 984 N (220 lbs.) with a standard deviation of 375 N (84 lbs). For toenailed connections, the average pull-out strength was 1313 N (295 lbs) with a standard deviation of 304 N (68 lbs). Canfield et al. (1991) conducted similar pull tests with similar results. However, they could increase the average pull-out strength to 1842 N (414 lbs) if the wood did not split when nailed. By comparison, Canfield et al. (1991) also conducted pull tests on metal "hurricane" clips and found an average strength of 5341 N (1200 lbs)

depending on the type of clip used. Thus, a metal clip can be about three times stronger than a 16d (8.9 cm or 3.5 in) toenailed connection (Figure 5).

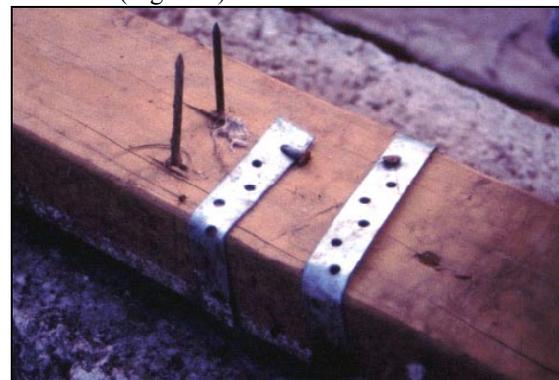
Figure 6. Metal straps held the bottom plate in place, however, failure occurred where the wall stud was straight-nailed through the bottom plate.

Besides anchor bolts, bottom plates are attached to the concrete slab with metal straps, shot pins, or cut nails. Metal straps can be just as effective as bolts in anchoring the bottom plate to the foundation if they have proper thickness and are installed correctly (Figure 6). The straps are typically made from 18 gauge metal (1.2 mm or .0478 inches) and are perforated for the fasteners. Steel shot pins look like thick nails and literally are shot into the foundation with a powder actuated hammer. Shot pins are typically 7.6 cm (3 inches) long and have an accompanying washer (Figure 7). Unfortunately, cut nails sometimes are used to secure the bottom plates to the foundations. Cut nails are easily pulled through the bottom plate when the plate is uplifted or rotated. Building codes do not allow the use of cut nails, however, some building officials have allowed cut nails to secure interior (not perimeter) walls. Unfortunately, we have found many homes where cut nails were installed around the perimeter of the foundation (Figure 8).

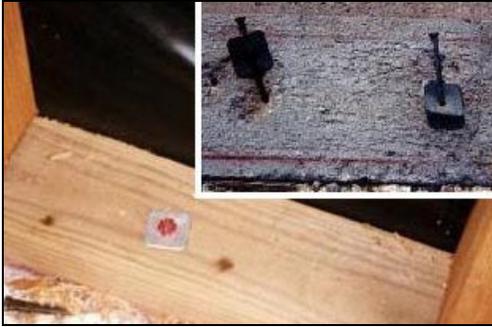
Figure 7. Shot pin with attached washer in the bottom plate. Inset photo shows aftermath of tornado where bottom plate broke around the fasteners.

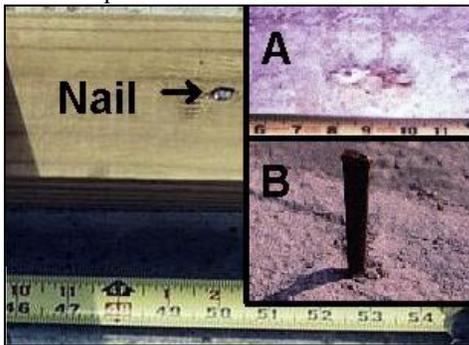
Figure 8. Cut nail in the perimeter bottom plate was a violation of the local building code. Inset photograph A shows scrape mark in the slab after wall slid off foundation. Inset photograph B is a cut nail left in the foundation after home was blown away.

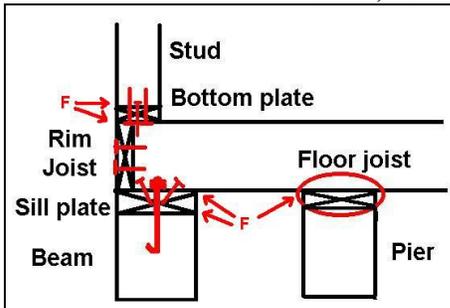
Figure 9. Typical pier and beam foundation showing connections and failure points (in red). However, piers are rarely attached to the flooring (circled).

Pier and beam foundations usually are made of different materials. Piers can be wood, loose block, masonry, or concrete. Perimeter grade beams are usually poured-in-place concrete or masonry. The same types of anchors are used to secure the house to the beams as with concrete slab foundations. However, floors are supported by the piers and rarely anchored (Figure 9). Note the floor platform separates the walls from the foundation, resulting in

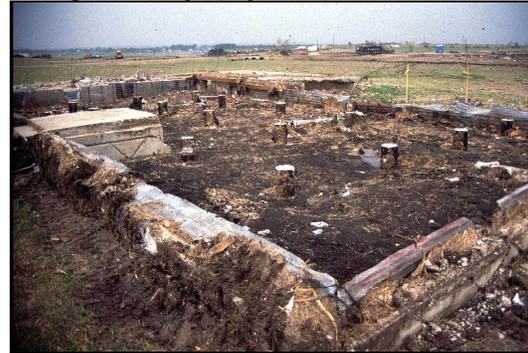
Figure 10. This home shifted and disintegrated from its wooden pier and concrete beam foundation. Floor joists were not attached to the piers.

more nailed connections. In general, the more nailed connections in a foundation, the greater the chances for a poor connection. The authors have identified failures at each of the nailed location points in this type of foundation. Usually, the anchor bolted sill plate remains. Homes on pier and beam foundations tend to shift off their foundations and sustain more catastrophic damage (Figure 10).

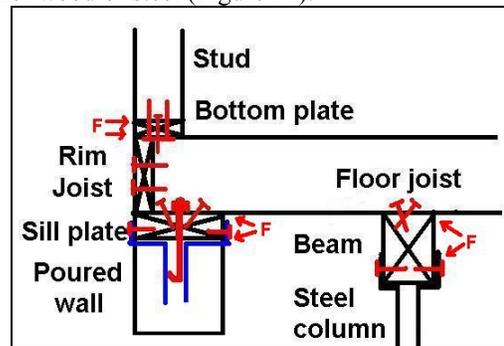
Figure 11. Typical cross section of a poured concrete wall foundation showing nailed and bolted connections with failure points (in red) and strapped connections (in blue). Center beam is wood or steel.

Poured concrete wall foundations are found in homes that have basements or crawl spaces. A concrete footing supports the foundation wall. The wooden sill plate is either bolted or strapped around the perimeter of the foundation. Floor joists typically are toenailed to the sill plate. A center beam extends across the middle of the basement or crawl space and is supported by columns and slotted into the perimeter wall. The center beam and columns are either wood or steel (Figure 11).

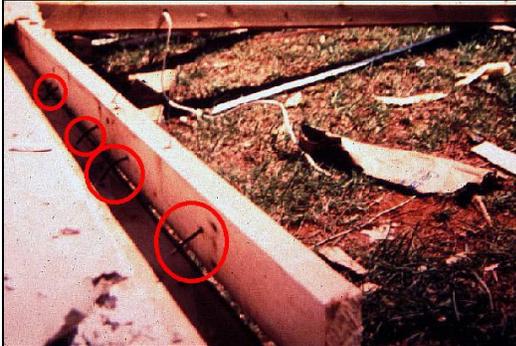
Figure 12. Straight-nailed bottom plate pulled out of the floor as the wall rotated. This was an inherently weak connection (circled).

A common failure point is where the bottom plate is secured to the floor. The bottom plate is straight nailed to the floor at certain intervals and the nails usually miss the underlying floor joists. Thus, this

connection has little resistance to lateral wind loads and the connection simply pulls apart as the wall is rotated (Figure 12). In many instances, the authors have found nails driven into the open joint between the rim joist and the floor joist leaving the wall virtually unattached. The floor platform usually remains if properly anchored to the foundation.

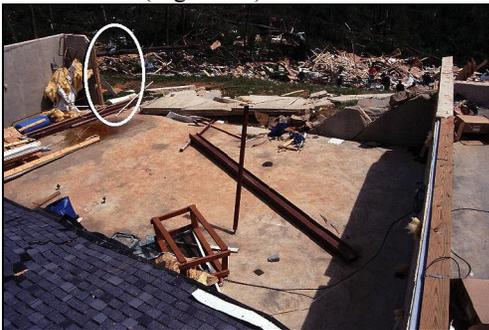
Figure 13. Exit door weakened the concrete wall foundation (circled). The foundation wall rotated and broke apart at the opposite corner. Steel rebar was used only at the wall corners. The house was pushed into the ravine in the background.

A more catastrophic failure occurs when the connection between the floor joists and sill plate fails. This results in the entire home sliding off its foundation. The authors also have found no attachment of the center beam to the floor joists especially if the center beam was steel. Also, doors and windows in the foundation wall can weaken its lateral resistance leading to overturning of the foundation wall (Figure 13).

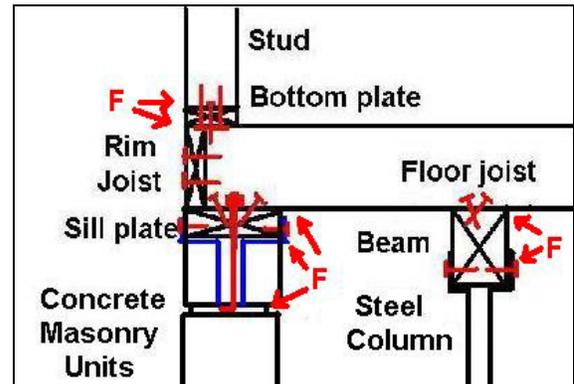
Figure 14. Typical cross section of a masonry wall foundation showing nailed and bolted connections (in red) and strapped connections (in blue). Center beam is wood or steel. Failure of this foundation type frequently occurs at areas denoted by the letter "F".

Masonry wall foundations are constructed with concrete masonry units (CMU). These units have open cells that are stacked in a common pattern with mortared joints. The connection of the house to the foundation is similar to that of concrete foundation walls. However, the top cell is usually filled with

mortar or concrete where the anchor bolts or straps are placed (Figure 14).

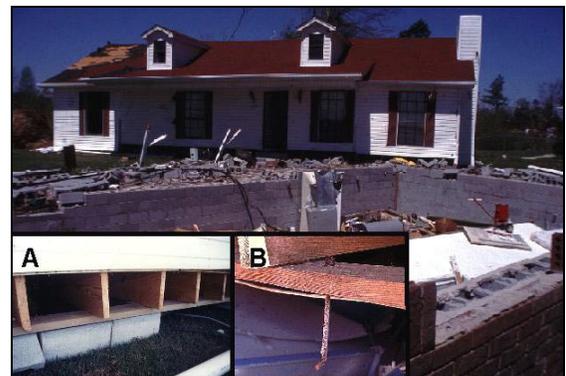
Figure 15. This home shifted off its foundation when the masonry foundation failed. Inset photograph A shows that the top row of masonry was attached with J-bolts as shown in inset photograph B. Note how little damage there was to the roof.

Unreinforced concrete masonry foundations are inherently weak in resisting lateral and uplift forces and frequently fail causing the house to slide along with the top row of concrete masonry (Refer to Figure 15). Interestingly, building codes in high wind areas require steel reinforcement to extend through the cells all the way down into the footing.

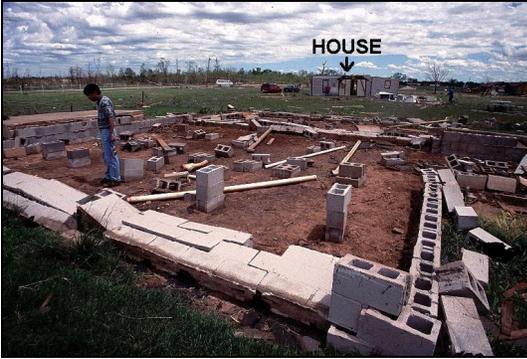
Figure 16. Unanchored home on stacked CMU foundation slid 90m (295 ft) off its foundation.

Homes constructed on loosely stacked brick or block foundations are not anchored and can be easily shifted from their foundations (Figure 16). Such homes can be "swept clean" from their foundations resulting in F-5 damage on the Fujita scale with wind speeds less than 45 m/s (100 mph).

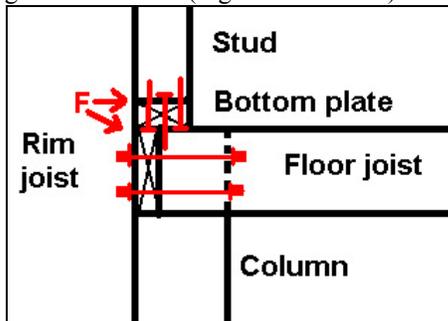
Figure 17. Typical cross section of home elevated on timber piles, concrete or masonry columns. Floors are usually bolted or strapped to the columns (in red). Common failure points are the nailed connections where the wall is attached to the floor.

Homes elevated on timber pilings, or concrete or masonry columns usually have substantial anchoring of the floor system. Weak points in this type of construction are where the bottom plates are nailed to the floors or where the wall studs are nailed to the bottom plates. Use of hurricane clips or straps can provide a much stronger connection provided they are installed properly and are protected from corrosion due to salt exposure. Wind damage to these homes usually involves loss of the walls leaving the floor intact (Figures 17 and 18).

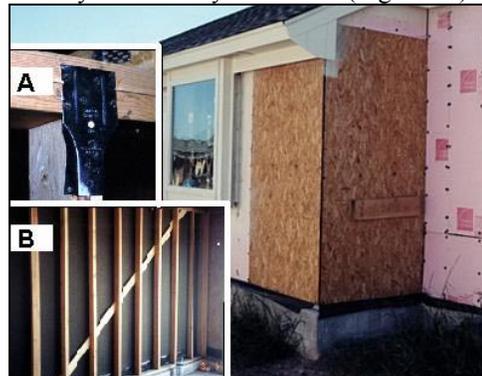
Figure 19. Installation of solid sheathing at wall corners helps stiffen the frame. Top plate clips as shown in inset photograph A and diagonal bracing as shown in inset photograph B also stiffen the frame.

Wood-framed walls need to be braced properly to stiffen the frame and resist racking from lateral loads. At a minimum, diagonal bracing or "let-ins" are required at all wall corners. Typically, wall studs are notched to receive a wooden board that extends diagonally from the top plate at the wall corner to the bottom plate and is nailed to the studs. Plywood or oriented strand board (OSB) is some times utilized at the wall corners, especially when diagonal bracing cannot be installed due to an intervening window or door (Figure 19).

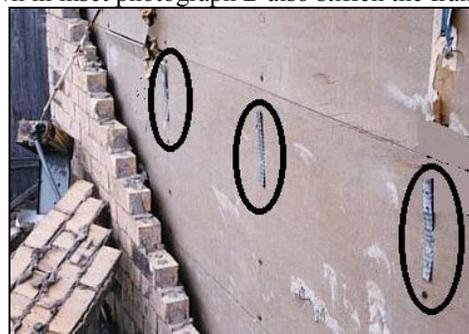
Figure 20. Brick ties (circled) were installed on this home but not engaged into the mortar joints. As a result, wind easily toppled this unanchored wall.

Loss of brick veneer is a common problem due to improper attachment of the masonry to the wood-framed wall. Corrugated brick ties or wires must be imbedded at least two inches into the mortar joints and attached properly to the wall. Walls that are not attached properly are free-standing and can be moved even by applying hand pressure. Such walls can topple easily in relatively low winds (Figure 20).

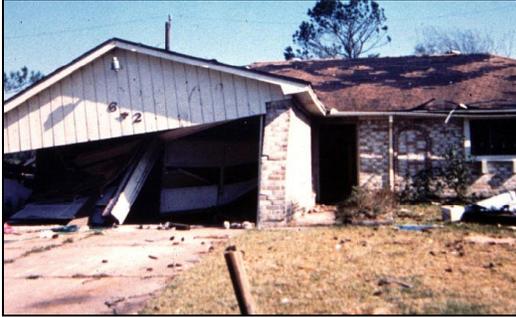
Figure 21. Inward failure of garage door led to outward failure of sidewall and collapse of the garage. Note little damage to remainder of home.

Weak links in wall systems are large windows or doors that interrupt the continuity of the framing. In addition, failure of windows and doors allows wind to enter the building increasing internal pressures that can help lift the roof and push out perimeter walls. Garage doors are inherently weak and often fail in wind speeds as low as 36 m/s (80 mph). The doors buckle or pop off the door tracks allowing the wind to enter the garage (Figure 21).

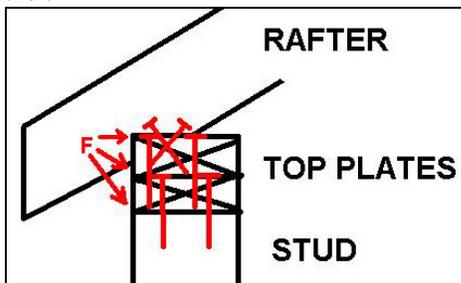
Figure 22. Typical cross section of roof/wall top plate showing nailed connections and common failure points (in red).

Roof systems typically are held in place by gravity. Thus, minimal attention is given to wind uplift effects. Typically, the rafters or trusses are toenailed to the wall top plates and this type of connection will meet most building codes (Figure 22). However, this connection is inherently weak when uplifted. Rafters or trusses will break away from the top plates. It is less common for the top plates to separate. Metal straps or clips can secure all of these members together.

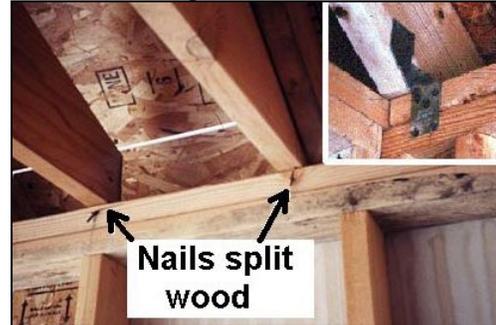
Figure 23. Nails driven through rafters and ceiling joists protruded through the top plate and split the wood. A better connection would have been to install metal clips as shown in the inset photograph that places the nails in shear (strong) instead of tension (weak).

The authors have found numerous examples where rafters and trusses were not fastened adequately to the wall top plates. Nails had split the wood or were driven through knots or other defects in the wood (Figure 23). As a result, the entire roof was susceptible to being removed in relatively low wind speeds. Properly installed hurricane clips or metal

straps can strengthen this connection greatly. A house that is missing its roof usually had poor attachments at the tops of the walls.

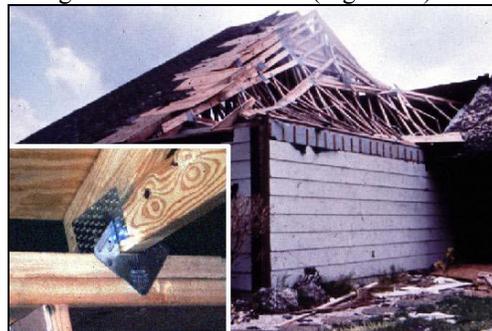
Figure 24. Toppled roof trusses due to a lack of lateral bracing. A metal bracket (inset photograph) along with proper wooden blocking between the trusses would have prevented rotation of the trusses.

Rafters and trusses require proper cross bracing to resist lateral wind forces. Installation of ridge blocking and metal brackets can prevent the trusses from falling down like dominoes. Although gable ends are non-structural components, they are susceptible to being blown inward or outward depending on the wind direction (Figure 24).

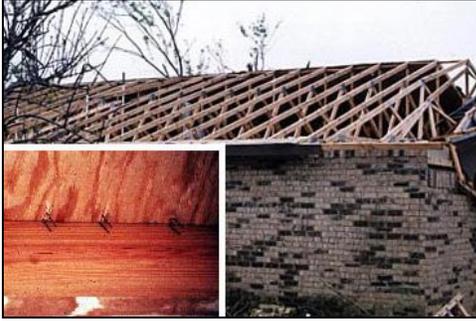
Figure 25 House that lost all of its roof decking on the leeward slope. Close inspection revealed that staples missed the underlying rafters (inset photograph).

Commonly, pneumatic guns are used to drive fasteners into the decking and in some instances, the fasteners miss the underlying framing. As a result, the roof deck is not attached and is quite susceptible to being removed in the wind. The authors have found entire sheets of plywood fully clad with roof shingles in the debris around the home. Exposure of the rafters and trusses usually indicates inadequate deck attachment (Figure 25).

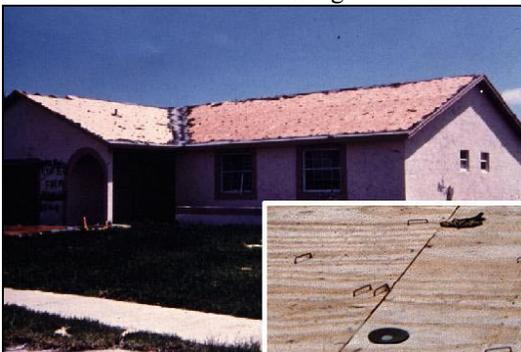
Figure 26. Poor installation of the roof covering on this home led to its complete removal. Staples were installed crooked and under-driven (inset photograph).

There are many different types of roofing materials on residences including asphalt shingles, tile, metal, wood shingles, shakes, etc. Each industry has guidelines available for proper installation of the roofing product. Installation instructions usually are printed on labels accompanying the roofing product indicating the proper size, number and spacing of fasteners. Roof coverings also must meet the minimum wind uplift requirements as stated in the building codes. However, the authors have found numerous deficiencies with installations of roof coverings that have led to their removal in relatively low wind speeds (Figure 26). Common roof installation errors include placing fasteners too high on the product, overdriving, under-driving, or orienting the fasteners incorrectly. Tile roofs secured with mortar tend to unbond leading to tile removal.
