Effects of Hail-Caused Dents on the Thermal Performance of Insulation under Single-Ply Roofing

By Steven R. Smith, PE; Robert Danielson, PE; and Cory Hurtubise, EIT

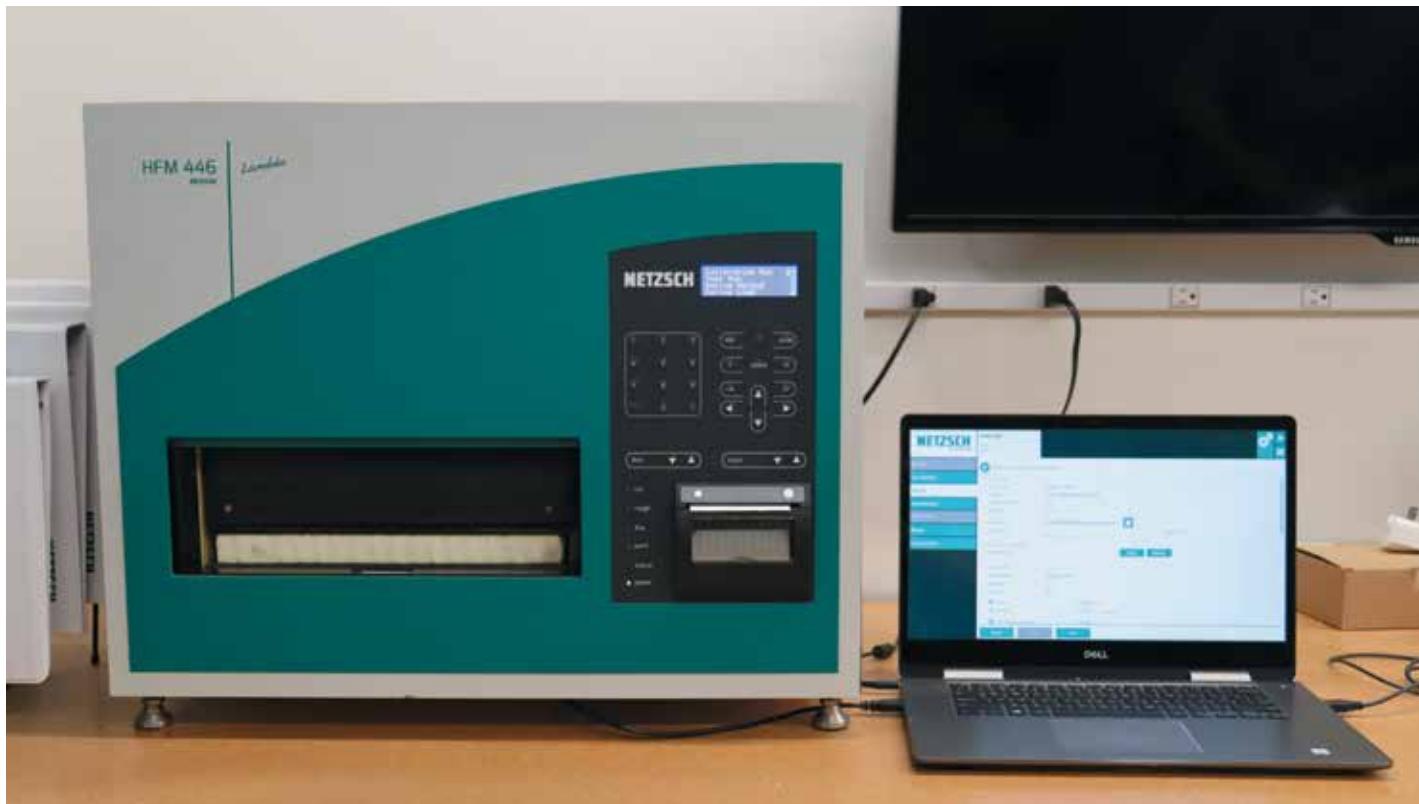
Figure 1. Heat flow meter test setup.

Haag uses a heat flow meter (HFM) to evaluate the thermal performance of roof insulation and measures the thermal resistance to conductive heat flow (*R*-value). The HFM test chamber is thermally insulated and contains two temperature-controlled plates. Both plates are fitted with heat flow sensors and thermocouples. The upper plate is maintained at a constant higher temperature, and the lower plate is maintained at a constant lower temperature. The insulation sample is placed onto the lower plate within the chamber, and the upper plate is lowered onto the insulation sample. The thickness of the insulation (distance between the two plates) is measured by the HFM. During a test, a thermal equilibrium condition is achieved, and steady-state heat flow through the insulation is measured. **Figure 1** shows the HFM test setup.

The HFM used in this study was a Netzsch Lambda 446, which has a published accuracy of $\pm 1\%$ to 2% .⁴ (Note: The trade name is mentioned in the text to specify adequately the experimental procedure and equipment used. Its identification does not imply recommendation or endorsement by IIBEC.) The manufacturer visits the Haag laboratory annually to calibrate this HFM.

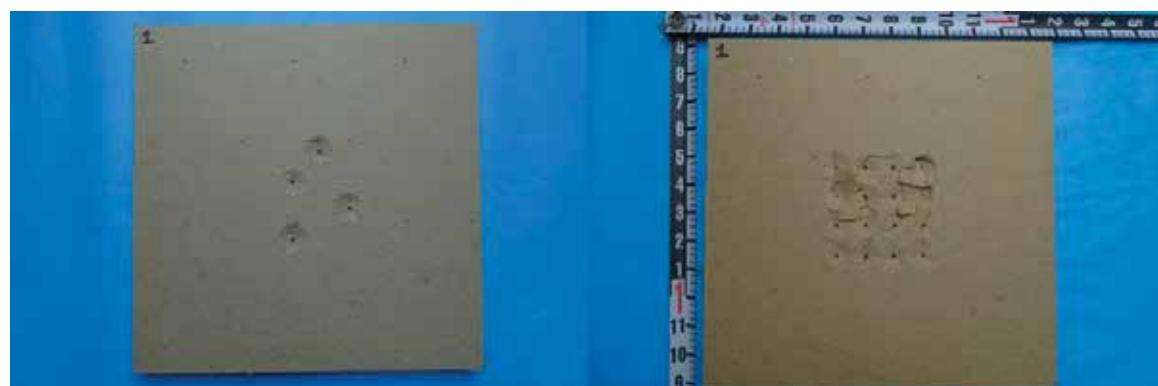
Figure 2.
Polyisocyanurate insulation specimens for test run 3 (left) and test run 7 (right).

Heat flow is measured in the HFM within a 4 \times 4 in. (100 \times 100 mm) region in the center of the test chamber (metered region). A template was used to precisely position a 1-in.-diameter (25-mm) steel ball bearing halfway into the insulation, forming semispherical dents in the insulation. A 4 \times 4 in. (100 \times 100 mm) grid pattern was made such that 16 symmetrical locations of the insulation within the metered region of the HFM would be dented. A random-number generator was used to select the order in which the locations were dented, and the same pattern was followed for each test run to account for possible variability due to geometric differences. The thermal resistance of the insulation was measured before and after denting. Seven different dent configurations were tested. **Table 2** summarizes these configurations, and **Fig. 2** presents two examples.

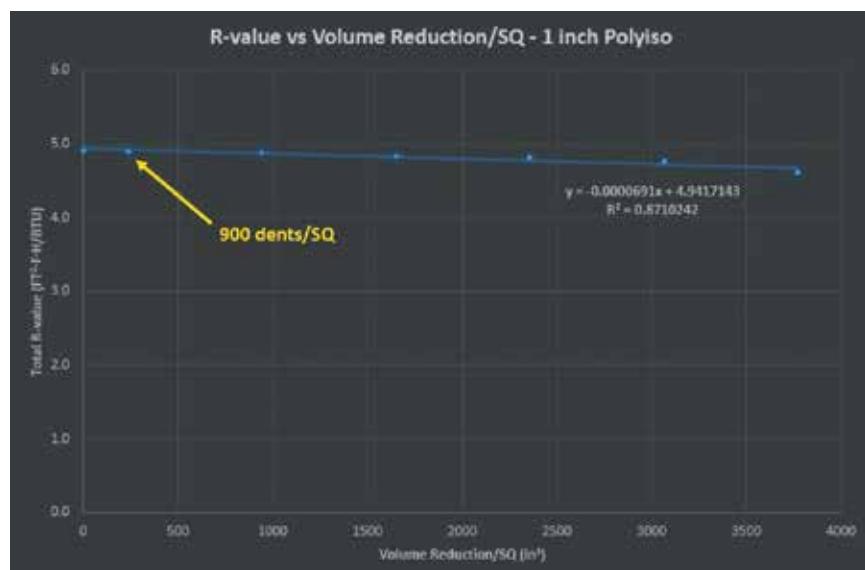
Figure 3. Plot of R-value versus volume reduction for 1-in.-thick polyisocyanurate (polyiso) insulation. Note: Although 900 hail-caused dents per roofing square (SQ = 100 ft² [9.3 m²]) is shown on the graph for reference, most hailstorms produce far fewer dents per SQ. 1 in. = 25.4 mm; 1 in.³ = 16,400 mm³.

The graph in Fig. 3 plots the total *R*-value of 1-in.-thick (25-mm) polyiso insulation versus volume reduction due to denting. Figure 3 illustrates a gradual, linear reduction of *R*-value with increasing volume of 1-in.-diameter dents.

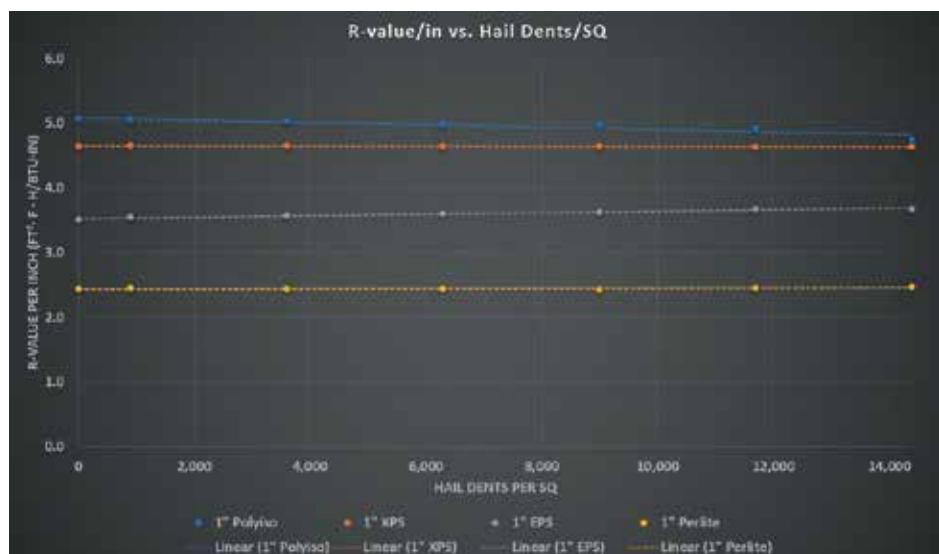
Figure 4. Plot of insulation R-values versus hail-caused dents per roofing square (SQ = 100 ft² [9.3 m²]). Note: 1 in. = 25.4 mm.

Similar analysis was conducted for each configuration of denting for each insulation type and thickness tested. **Figure 4** is a graph of the results for all four types of 1-in.-thick (25-mm) insulation tested. Measurements were deemed to be statistically significant when measured *R*-values deviated from

the nondented specimens (test run 1) by more than 1%. Note that the plots of *R*-value for XPS and perlite are essentially flat and the changes in *R*-value for these insulations were insignificant. The plot for polyiso insulation has a slight downward slope (as previously shown in Fig. 3), and the plot for EPS has a slight upward slope. Analysis of data for polyiso and EPS insulations showed insignificant changes in *R*-value with four or fewer dents added (3600 dents per roofing square), and small but significant results with more than four dents in the metered region of the HFM. *R*-value measurements of XPS and perlite insulation remained within 1% of the test run 1 values even after test run 7, which represented 14,400 hail-caused dents per roofing square.

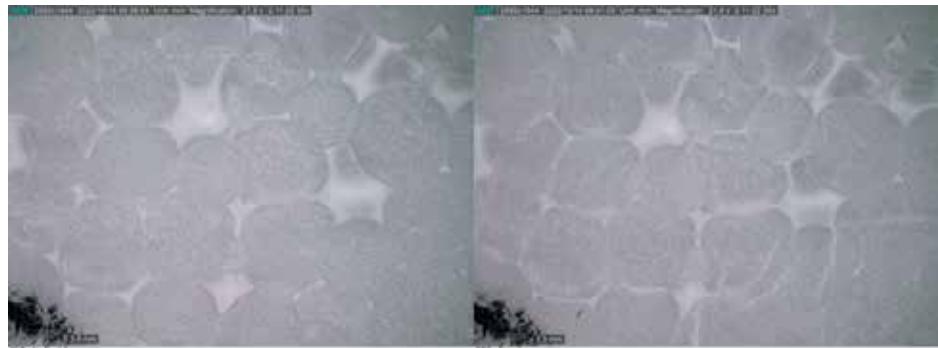
Figure 5. Expanded polystyrene (EPS) specimens: undented (left) and dented (right).

A result of particular interest was the slight increases in the *R*-value of EPS insulation as more dents were added. In a part of our research that is outside the scope of this article, we examined EPS insulation under magnification before and after making a dent to better understand any physical changes that occur when EPS insulation is dented. We noted some of the EPS beads developed creases and had slightly separated from adjacent beads. These mechanisms could impede conductive heat transfer between individual beads to some degree, which could explain the slightly higher *R*-values that were measured. Also, the EPS tested was low density and relatively compliant, allowing most of the dent volume to rebound after denting. For this reason, compression of the EPS at the dents did not significantly alter the density of the insulation where dented. **Figure 5** presents micrographs of dented and undented EPS.

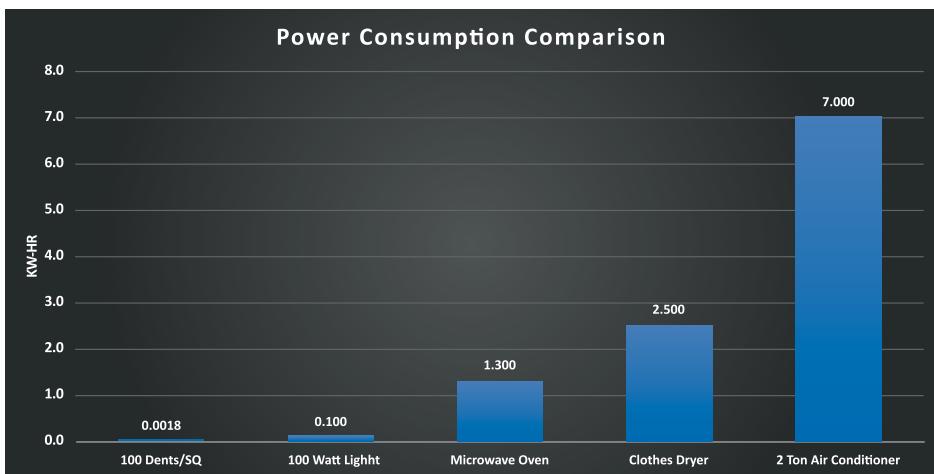
Figure 6. Power consumption comparison: hail-dented roofing square ($SQ = 100 \text{ ft}^2 [9.3 \text{ m}^2]$) versus selected appliances.

To put the magnitude of this estimate into perspective, Fig. 6 compares the 100 hail-caused dents per roofing square example to the power consumption of several common appliances.¹⁴ Interestingly, operating a single 100-W light bulb for one day would consume about 55 times the energy associated with the increase in thermal energy through the roof due to the hail-caused dents. The hail-related thermal energy increase would be roughly equivalent to having the light bulb on for about 26 minutes a day or running a 2-ton (7-kW) air conditioner for about 22 seconds per day, although these comparisons overestimate the effects of the dents because the roofing square example assumes the roof remains at peak temperature for 24 continuous hours each day.
