Effects of Sub-Severe Hail on Asphalt Shingles

A Forensic Engineering Position Paper Clarifying Evidentiary Boundaries Between Material Susceptibility, Normal Aging, and Hail-Caused Damage

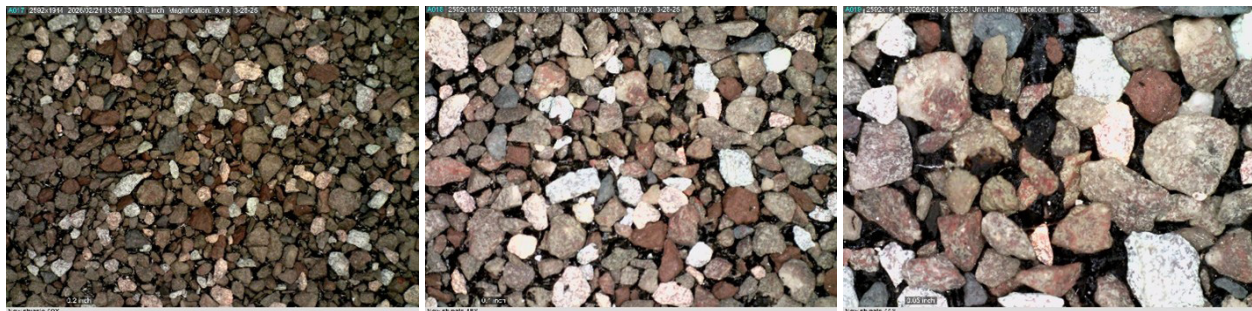
Figure 1: Surface of a new asphalt shingle under magnification. 10X (left), 18X (center), 40X (right)

To reiterate the key point discussed previously, long-term weathering also causes loss of granules, which can accelerate shingle deterioration, increasing the vulnerability to future hail damage, even in the absence of sub-severe hail. Figure 1 below shows examples of a new (never installed) asphalt composition shingle and demonstrates exposed asphalt between individual granules. Consequently, coating asphalt on granules is exposed to UV starting the day the shingles are first installed.
