WIND EFFECTS ON ASPHALT SHINGLES

Timothy P. Marshall*, Scott J. Morrison, Richard F. Herzog, Jeffrey R. Green
Haag Engineering Co.
Irving, Texas

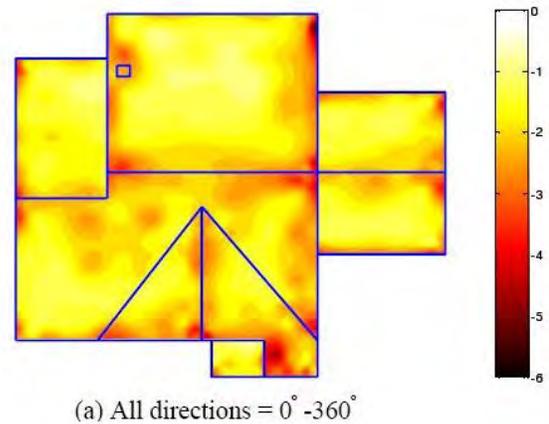
Wind interacting with a roof is deflected over and around it. As a result, uplift pressures develop on the roof. However, uplift pressures are not uniform and are highest along the windward corners, rakes, eaves, and ridges (Fig. 1). It is at these locations that wind uplift damage initiates especially with asphalt shingles that are not well bonded (Fig. 2). Wind flow in these areas is quite turbulent. Thus, it is important that the roof covering receive additional anchorage in these high wind uplift regions. The Federal Emergency Management Agency (FEMA 2005) has published guidelines on how to attach asphalt shingles in these areas which involve the application of adhesive dollops along the roof edge and between the asphalt shingles in high wind zones.

Figure 1. Peak negative uplift pressure coefficients (C_p) on a gable roof from a wind tunnel model. Wind directions were at 10 degree increments. From Liu et al. (2006)

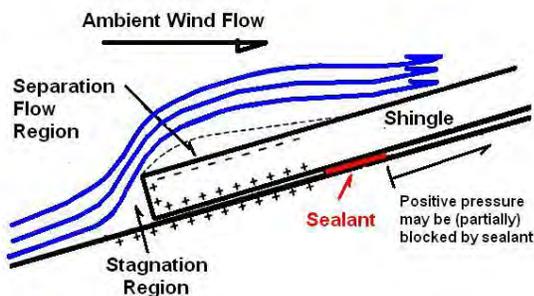
Figure 3. Idealized wind flow (blue lines) and resultant positive (plus signs) and negative pressures (minus signs) at the bottom edge of a shingle. From Peterka et al. (1997).

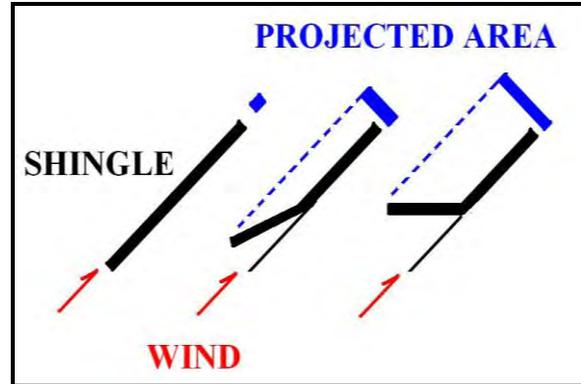
Figure 4. Idealized diagram showing the increase in the projected area (blue line) as the shingle is uplifted in the wind.

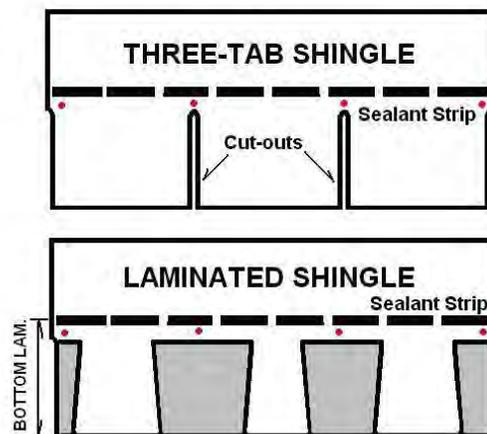
The two most common types of strip asphalt shingles are three-tab and laminated (Fig. 5). Both shingle types are comprised of glass-fiber or paper mats that are saturated in hot asphalt and top coated with granules. With three-tab shingles, two joints are cut out of the bottom half of the shingle primarily as a design feature. Laminated shingles have a top laminate and a bottom laminate. The lower portion of the top laminate has trapezoidal-shaped cut-outs whereas the bottom laminate is a solid shingle. The bottom laminate is only half the width of the top laminate and is adhered to the lower portion on the back side of the top laminate. The design of the laminated shingle gives the appearance of wood shingles. Both shingle types have sealant strips.

Figure 5. The two most common types of asphalt shingles are the three-tab and the laminated. At least four fasteners must be installed per shingle (standard application) as noted by locations of the red dots.

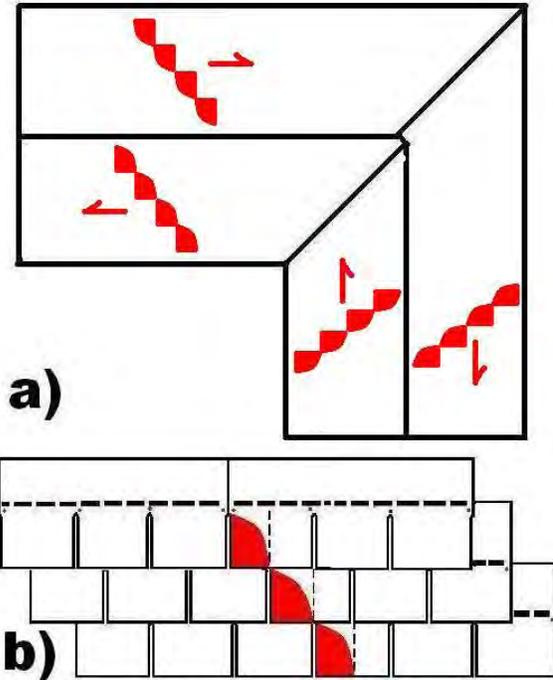
Shingles frequently are not bonded to the roof where they overlap an adjacent shingle. Poor adhesion of the sealant strip in combination with cyclic thermal expansion and contraction along the long dimension of the shingle causes the unbonded condition. Eventually, dirt and debris render the seal ineffective. The authors have found this condition on roofs around the U.S., and not just in hurricane prone regions.

The pattern of unbonded shingles depends on the manner in which the shingles were installed. Shingles installed in a racking or straight-up pattern typically have alternating overlaps not bonded to the underlying shingles. By comparison, shingles installed diagonally typically have left or right overlaps not bonded to the underlying shingles. Usually, unbonded overlaps can be found on each directional slope. Wind does not come from multiple directions with just enough force to unbond the shingle overlaps on different slopes. Refer to Figures 15 through 18.

Figure 15. Diagonal pattern of shingle overlaps not bonded to the roof: a) roof plan showing open laps (arrows) pointing in different directions, and b) idealized diagram showing red shaded region where tabs could be lifted unimpeded by hand. This pattern extends diagonally upslope depending on the manner in which these shingles were installed.

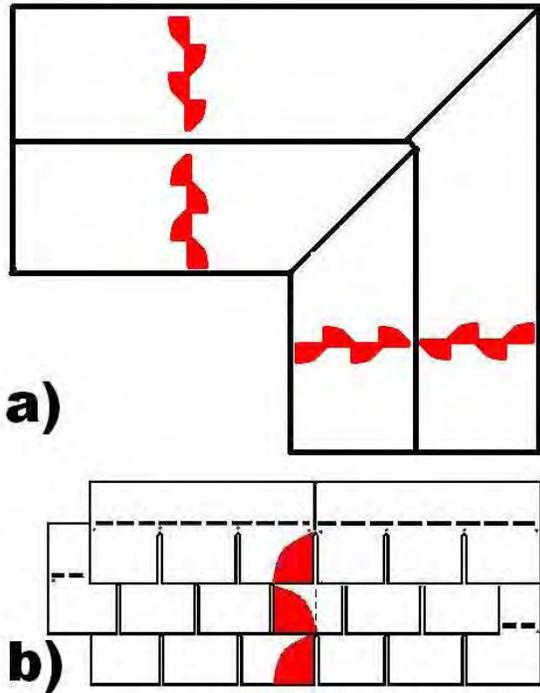
Figure 17. Straight-up pattern of shingle overlaps that are not bonded to the roof: a) roof plan showing alternating overlaps not bonded to the roof on each directional slope, and b) idealized diagram showing red shaded region where tabs were not bonded to the underlying shingles. This pattern extends vertically upslope in the manner in which these shingles were installed.
