Testing of Impact-Resistant Asphalt Shingles

By Steven R. Smith, PE;
Timothy P. Marshall, PE;
and Jonathan S. Goode, PhD, PE

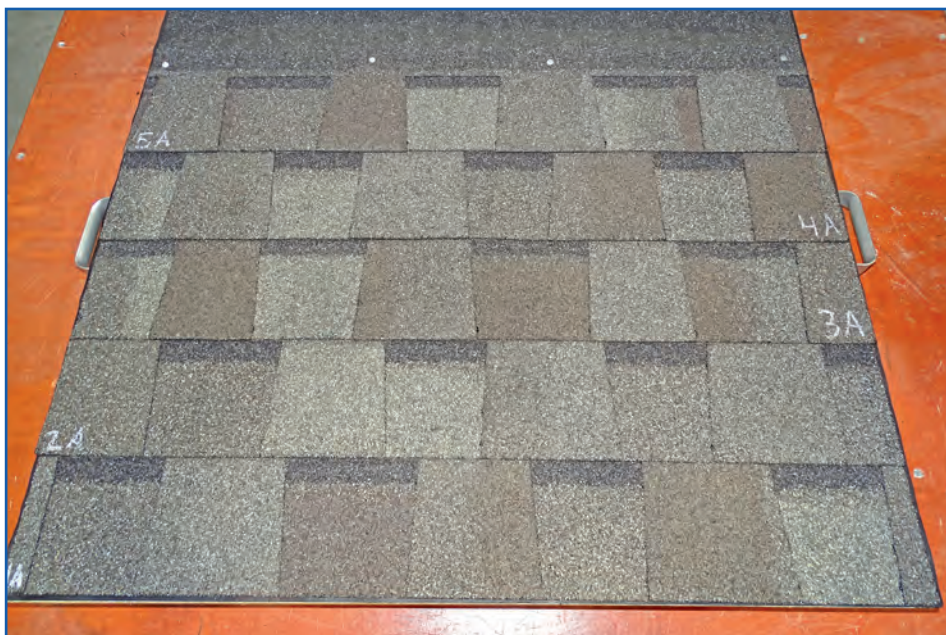
Figure 4 – Laminated shingle test panel.

standard laminated shingle profiles. Four of the tested shingles had additional reinforcement backing on the bottom surfaces of the shingles to increase tensile strength. Figures 4 through 6 depict typical test panels and typical reinforcement backing. One of the high-profile designs also featured asphalt modified with styrene-butadiene-styrene (SBS), a rubber compound that adds flexibility to the shingle. Table 3 summarizes characteristics of the tested shingles. The identities of the products and shingle manufacturers were withheld from this paper.

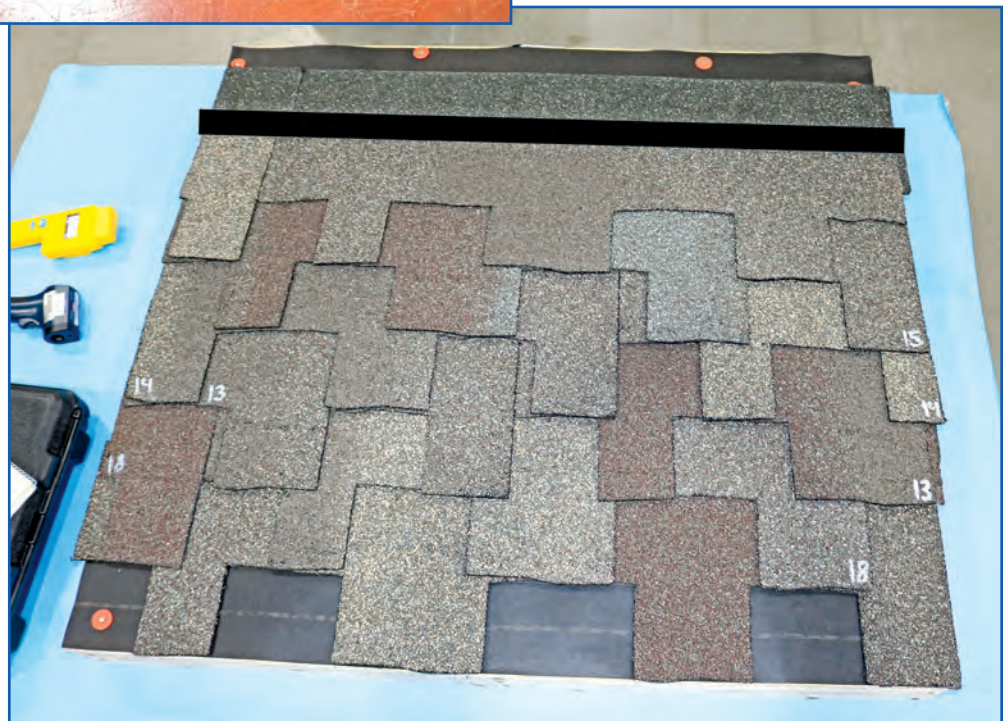
Figure 5 – High-profile shingle test panel.

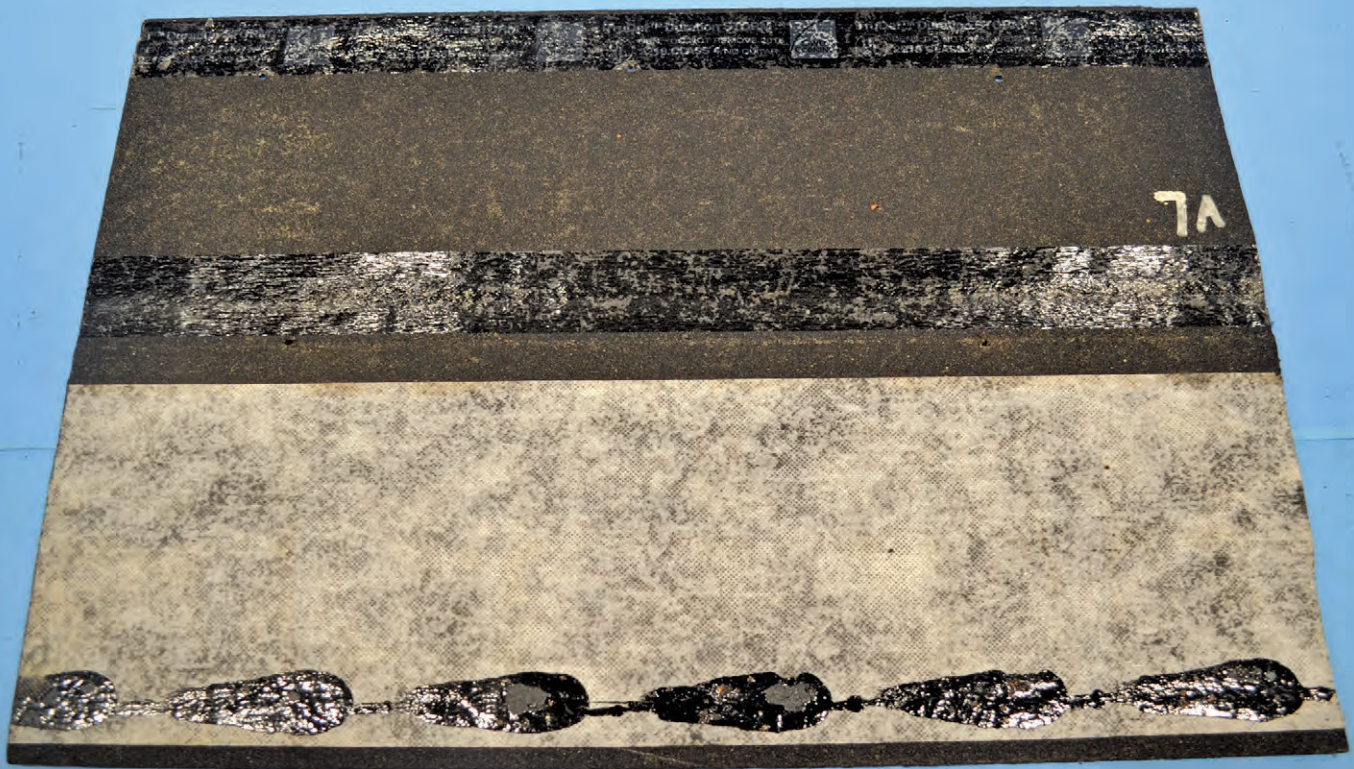
Figure 6 – Reinforced backing on an impact-resistant asphalt shingle.

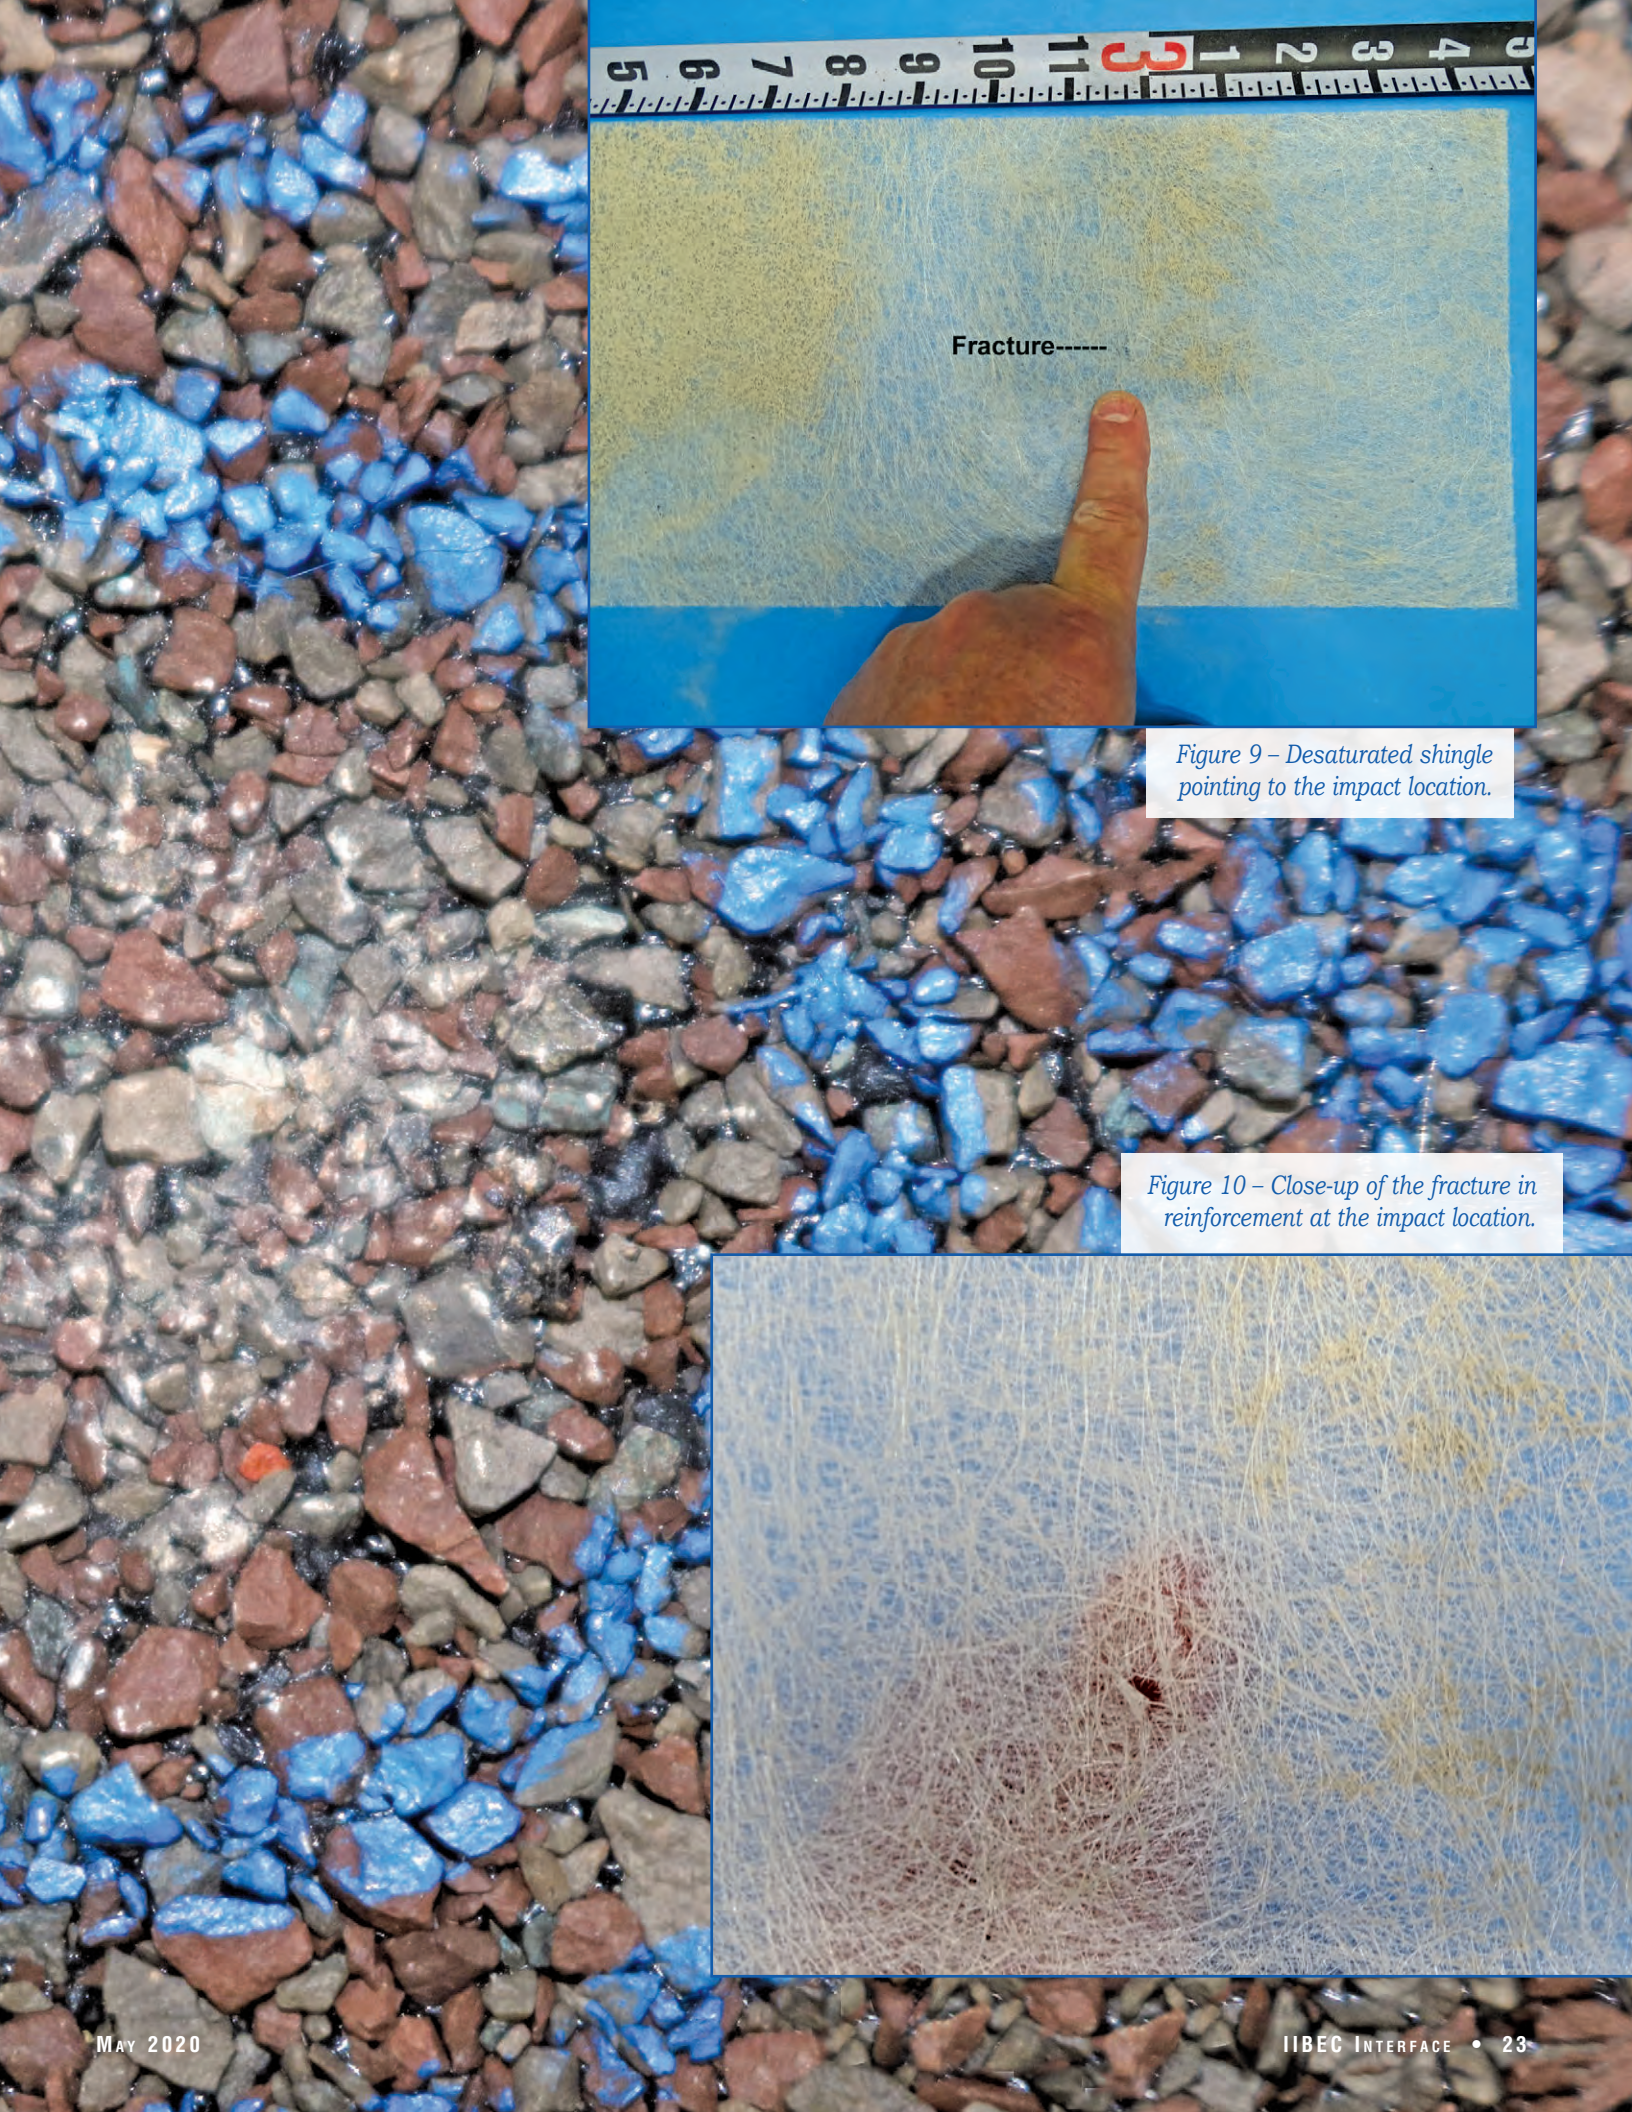
Figures 7 through 10 depict a Class 4 shingle after a set of Class 4 UL-2218 tests. Recall that the test procedure requires double impacts. Note the crushed granules are a cosmetic condition of the testing and are not considered in the test results. Any fracture visible on the bottom of the shingle constitutes a test failure; however, many of the

Figure 9 – Desaturated shingle pointing to the impact location.

Figure 10 – Close-up of the fracture in reinforcement at the impact location.

shingles exhibited conditions that appeared to be fractures but could not be visually confirmed. Desaturation of the shingle revealed a fracture in the reinforcement, which would constitute hail damage in field inspection/evaluation.
