PROTOCOL FOR ASSESSMENT OF HAIL-DAMAGED ROOFING

TIMOTHY P. MARSHALL and RICHARD F. HERZOG

Haag Engineering
Carrollton, Texas, U.S.A.

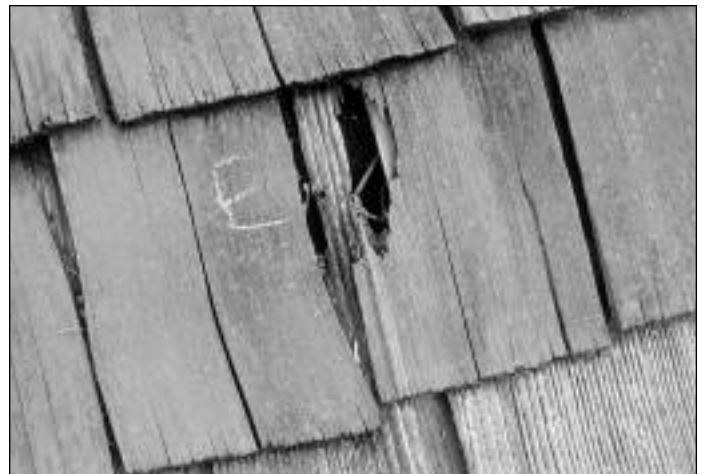
Figure 8. Eroded opening in a cedar shake.

Hail-caused punctures in a wood shingle or shake are discernible because sharp-edged openings expose unweathered wood of the underlying shingle or shake. Additionally, there still may be pieces of wood broken away by impact along the edges of the opening. Openings due to long-term water erosion, on the other hand, are contrasted by having smooth edges and thin wood around the opening. The eroded openings most commonly form just below the overlying butt of a shingle or shake or in the upper portion of the joint between shingles or shakes (Figure 8). The wood exposed on the underlying shingle or shake will be a weathered gray similar to other exposed areas of the wood. It can take approximately six to 12 months of exposure to weather, or oxidize, cedar from orange to gray. Areas that have an eroded opening often will have a comblike appearance, where the denser winter wood remains and the less dense summer wood has eroded.
