Testing Application Standard (TAS) No. 106 - Its Importance and Intended Use

In this month's blog post, we at Haag Engineering Co. (Haag) talk about the TAS 106 (*Standard procedure for field verification of bonding of mortar or adhesive set tile systems and mechanically attached rigid, discontinuous roof systems*). Within the forensic engineering, roofing, and insurance industries, we are experiencing continued use of the Florida Building Code's (FBC) TAS 106 for the determination of wind-related damage to tile roof systems. The objective of this blog post is to simplify, understand, and ultimately convey the importance and intended uses of the TAS 106.

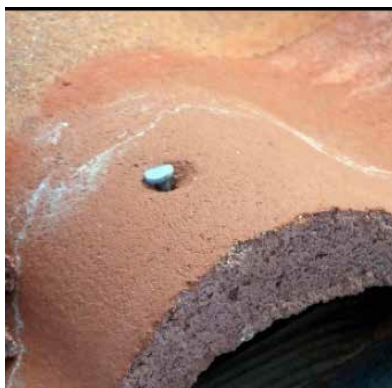
When mechanically fastened tiles are said to be “loose” or exhibit lift of 2 inches or more at the butt-end (tile nose), inspectors often attribute these conditions to wind uplift forces. By the nature of the installation, mechanically attached field tiles can be lifted by hand to some degree, and this is reflected within TAS 106 by the allowable threshold of 2 inches. These tiles are intended to be hung from fasteners, and correct fastener installation entails driving fastener heads nearly flush while providing an adequate gap between the head and the tile surface for thermal movement and to prevent breakage.

Figure 1: Correct Nail Fastener Installation

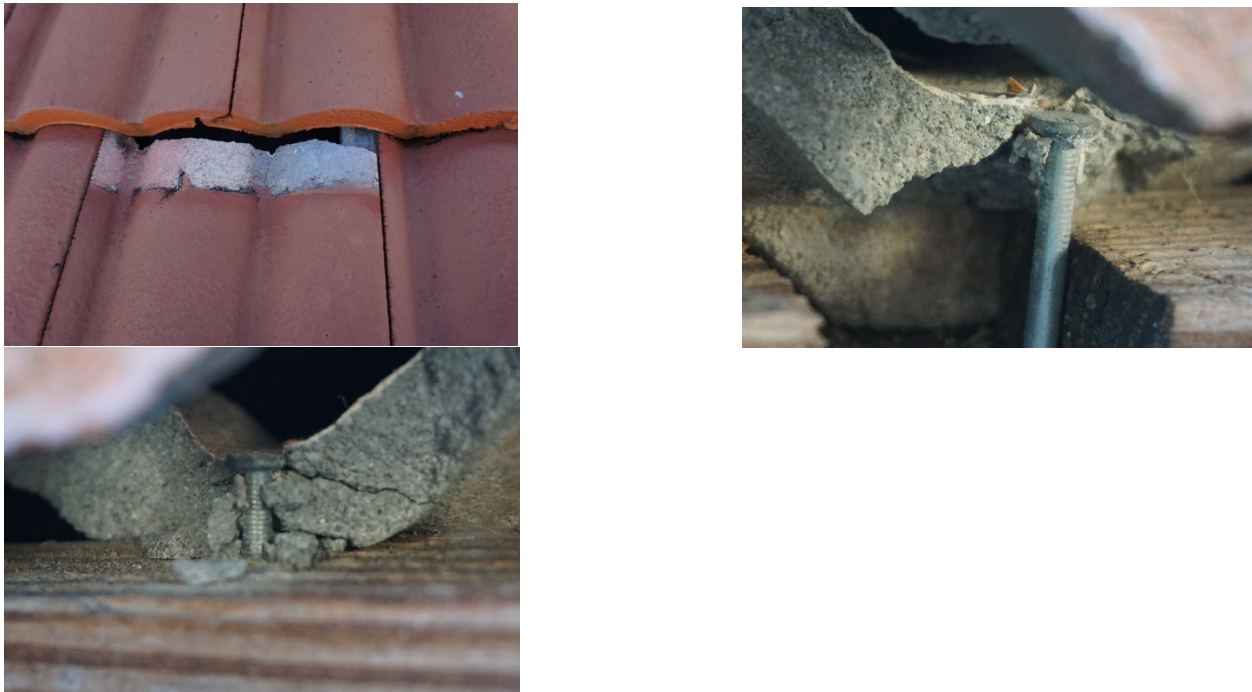
When fasteners are driven tightly against tile surfaces, tiles are prone to fracture during the attachment or as a result of inadequate space for thermal movement. Fasteners can also be underdriven, resulting in an elevated fastener. Depending on the extent of an underdriven fastener, this condition may result in a point load fracture, typically induced by foot traffic.

Figure 2: Fracture through the fastener hole caused by overdriven fasteners

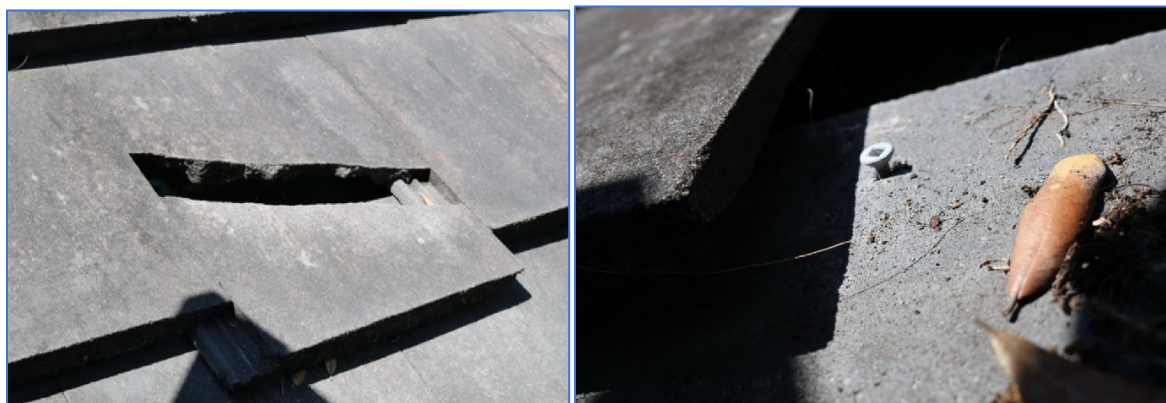
Figure 3: Tile fracture caused by an elevated underlying fastener

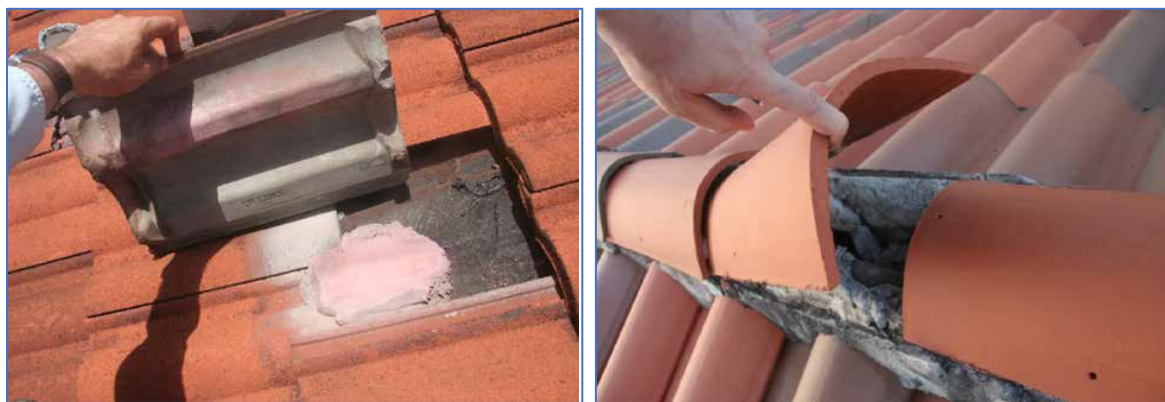
Unbonded (or not-bonded) mortar-set tiles that remain in place are commonplace and are not the result of wind forces. A bonded roof tile that is broken loose by wind uplift will not remain in place and/or be undisturbed; rather, wind forces great enough to break a bonded tile will also displace or remove the tile from the roof. Tiles that unbonded or never bond to the underlying substrate and remain in place can be caused by a number of factors, including the following: thermal stresses; installation conditions; and/or maintenance activities. Unbonded mortar-set tiles must be periodically reset with new mortar to keep them secure.

Figure 4: Unbonded or not-bonded mortar-set tiles that remained in place.

Let's discuss two common misconceptions related to the TAS 106 frequently encountered during roofing inspections; 1) lift at the butt-ends of mechanically fastened field tiles, and 2) unbonded or not-bonded mortar/adhesive set tiles that remain in place.
