Response of Test House to Vibroseis Vibrations and Environmental Forces

In response to public concerns about the damage potential of vibroseis vibrations from seismic exploration, Fina Oil and Chemical Company (now Total E&P USA, Inc.) sponsored full-scale testing of a typical residence. The test house was vibrated by four vibroseis trucks on both soil and asphalt surfaces at declining separation distances. Ultimately, the vibrators were 13 feet (4.0 m) from the front porch and 10 feet (3 m) from the front sidewalk. Peak particle velocities of the ground motions were about 1 in./second (0.4 cm/second) at the house foundation. As expected, the responses of the superstructure were strongly dependent on the frequencies of the ground motions. No damage to the house of any kind was produced by these vibrations, even though the vibrators were operating at 90% maximum output. Tests were also conducted away from the house to explore the vibration intensities and attenuation characteristics of the ground motions generated. The resulting vibrations were compared to previous work and found to be consistent with those results. Changes in crack width and associated weather-induced changes in t

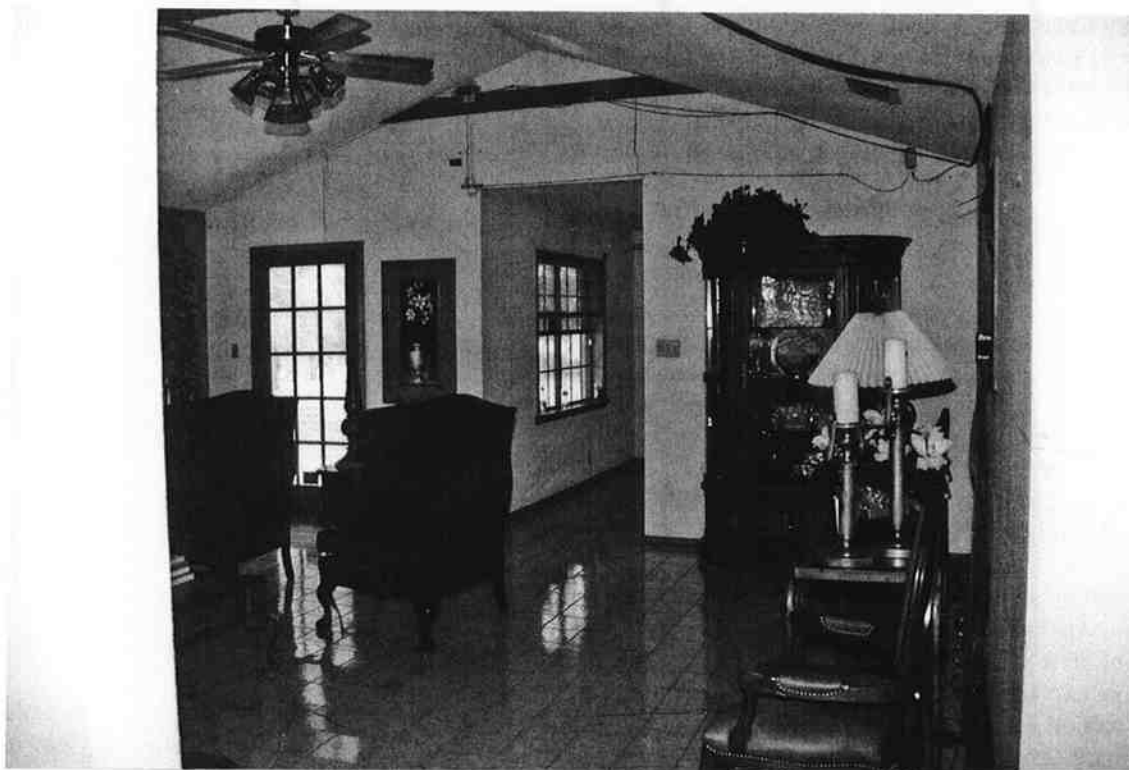
Figure 5. North end of dining room shown with the furnishings included in the testing program.

The living room features a fireplace and hearth in the west wall with an exterior masonry chimney. Bedrooms and bathrooms are located in the southern part of the building. Family living areas are in the central part, and the garage and laundry are located in the north end. During the vibroseis testing, the living room was furnished to represent conditions in a typical occupied residence. These furnishings included couch, chair, end tables, decorative curios and centerpieces, and wall hangings. The dining room was also furnished, but only with utility tables and stands for test equipment. The kitchen was stocked with common cooking utensils and tableware. A portion of the living room is shown in Figure 5.

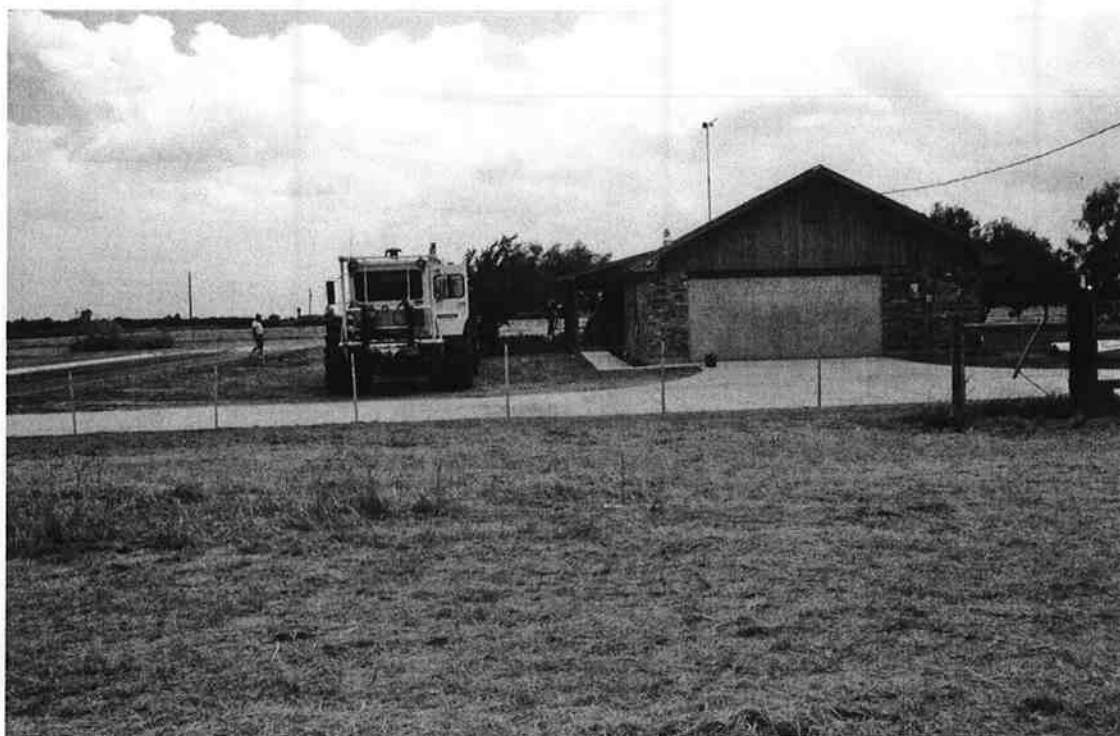
Figure 6. Vibrators beside test house, looking south.

The primary structural system above the foundation is a wood frame with wood-framed interior partitions. The roof system consists of a custom-framed, gable structure decked with plywood and surfaced with three-tab composition shingles. Interior walls were clad with gypsum wallboard and finished with conventional architectural materials such as paint, wallpaper, and stained wood. Exterior walls were clad with brick veneer and wood siding, which can be seen in Figure 6.

Figure 6 shows the trucks lined up next to the test house. This view is taken from the north end of the house looking south. It shows the concrete driveway in the foreground, with the sidewalk and front porch in the center of the photo. The new asphalt street is located to the left of the trucks. The weather station can be seen projecting above the roof at the far south end of the house. Figure 7 shows the trucks as viewed from the east, looking toward the front side of the house. The length of the line of vibrators is greater than the length of the house.

Three months before the vibroseis monitoring, a weather station was installed to record exterior conditions. The weather station can be seen in Figure 6, mounted on a pole at the south end of the house. Weather conditions were monitored from March of one year to February of the following year with a Davis weather station that recorded temperature, wind speed, humidity, and precipitation.

While monitoring the house response, vibrators were placed in lines both parallel and perpendicular to the long axis of the house. For the closest tests, the trucks were placed adjacent to and parallel to the house on both soil and asphalt surfaces, as shown in Figure 6. Shaking was noticeable inside the house, and containers with different fluid levels moved visibly at different times as the frequency changed. Doors, windows, cabinets, and drawers all vibrated perceptibly at different times as the input frequency changed.

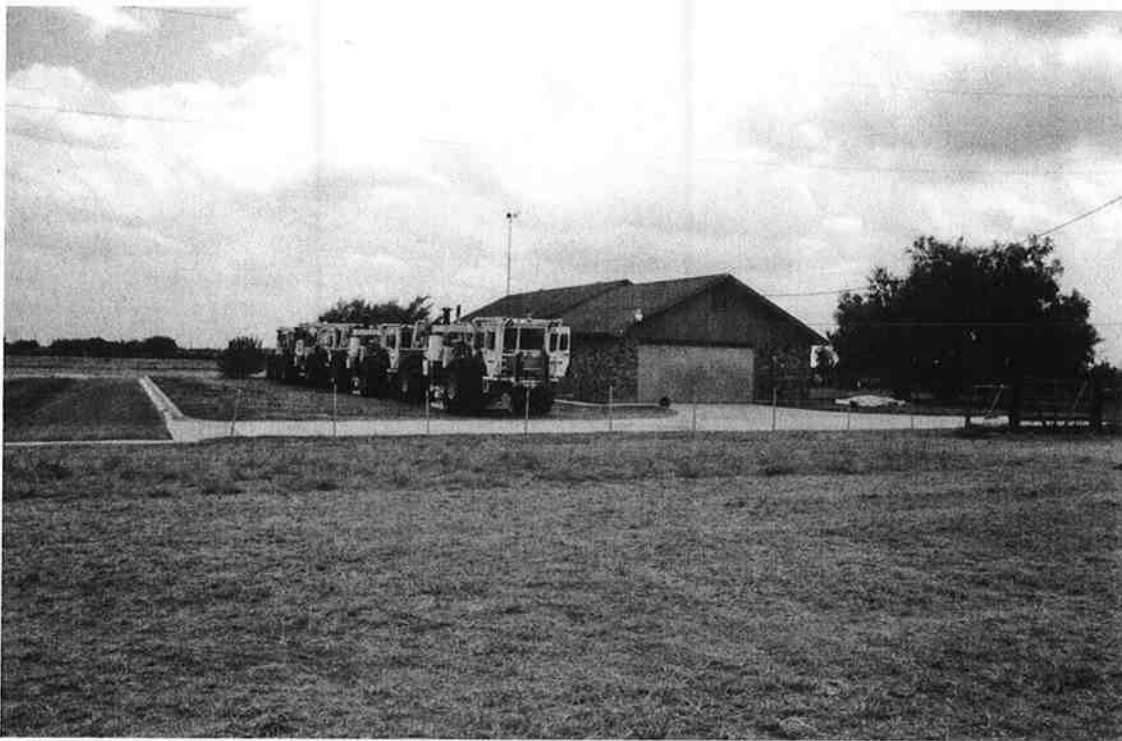
Figure 7. Vibrators beside test house, looking west.
